Scottish Coastal Archaeology and the Problem of Erosion

# Coastal Zone Assessment Survey

## Kintyre

The SCAPE Trust and the University of St Andrews  
November 2024

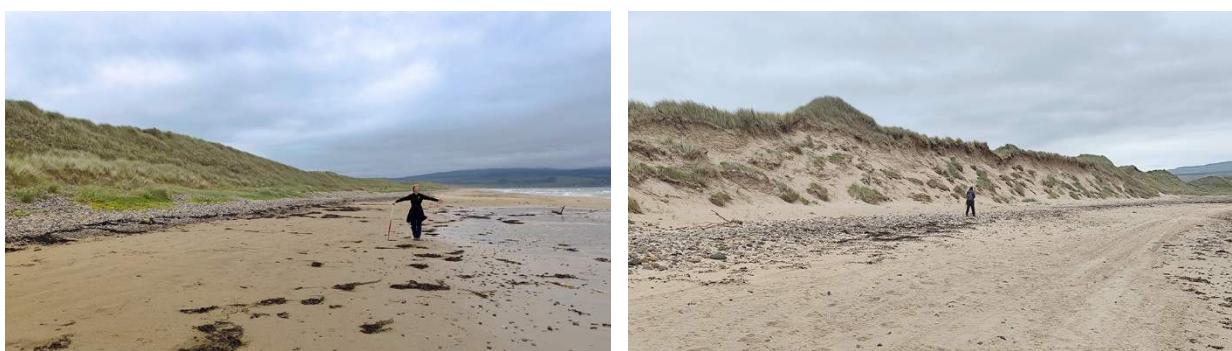
Along the longest stretch of sandy beach backed by dune systems at Machrihanish Bay (Figure 4) we found that there was landward migration of the mean high-water springs in the order of 5m to 20m since 1898 along about half of the beach. We also observed stretches where the position of the MHWS had not changed or migrated slightly seaward. The movement in the relative position of the MHWS didn't necessarily coincide with movement in the position of the coast edge or unstable sections. At least half of the dune faces appeared stable and well-vegetated, interspersed with areas of slumping especially of the higher dunes.

*Figure 4. The figure stands on the 1898 MHWS around halfway along Machrihanish Bay at a stable section of the dunes. Just beyond is an actively eroding high dune face.*

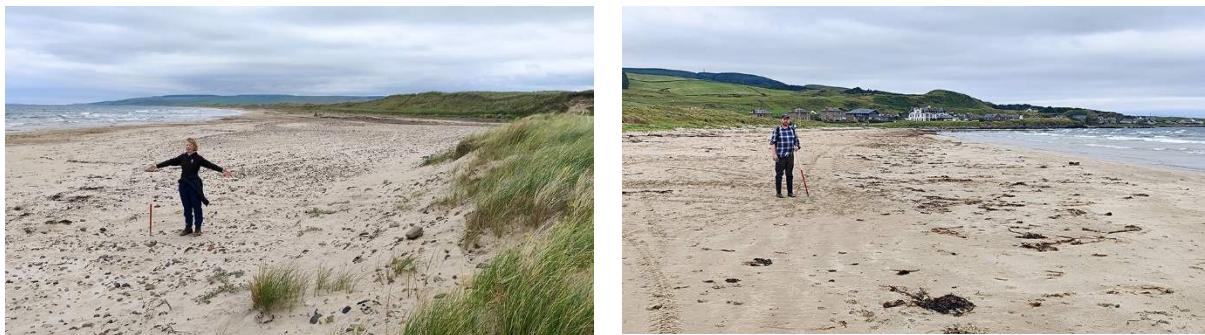
Machrihanish Water has progressively moved north since 1898, and this may account for the high rate of past migration of the MHWS here which has affected the modelling of future erosion.

*Figure 5. Figure standing on the 1898 MHWS at the south end of Machrihanish Bay with the current outflow of Machrihanish Water in the background. In the second photograph the person is standing on the position of the river outflow as mapped in 1898 with the villa.*

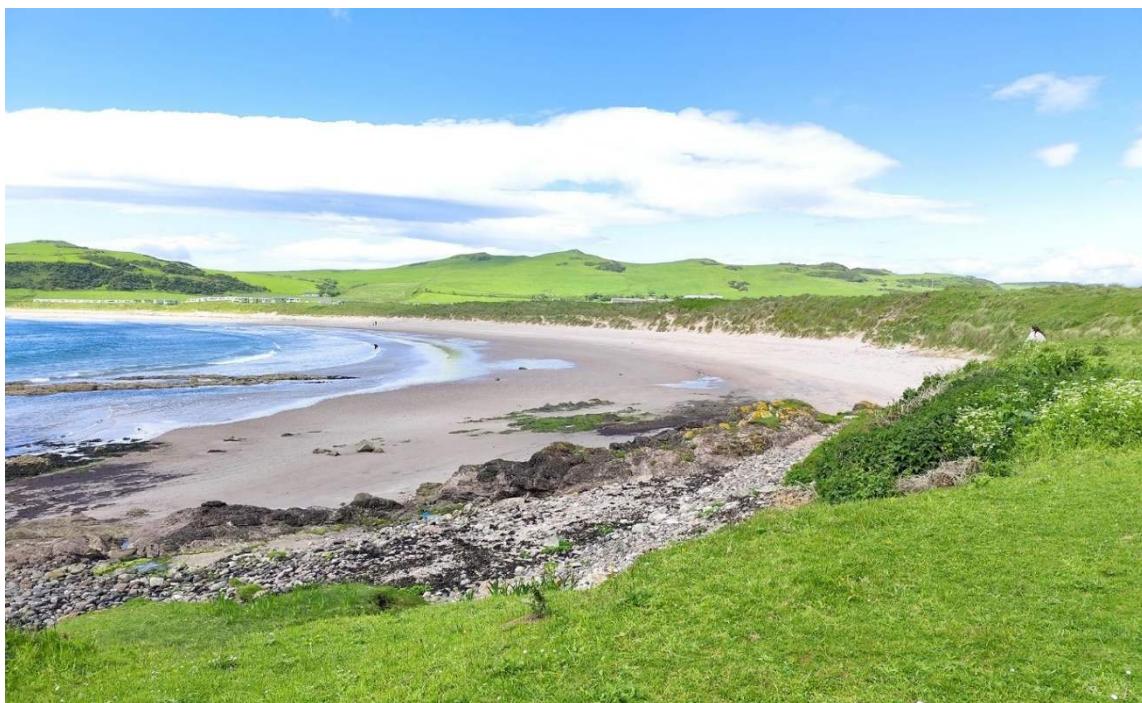
At the southern tip of the Kintyre peninsula, we surveyed two of the three sandy beaches backed by low dunes, Dunaverty Bay (Figure 6) and Brunerican Bay. These appeared to be stable with some sand blow against the front of the dunes, which is probably seasonal. A site of a millstone quarry at the east end of Brunerican Bay is a useful marker of the movement of sand across the beach profile. A rough-out millstone at the top of the beach is usually deeply buried but exposed periodically in winter storms.

*Figure 6. The sweep of Dunaverty Bay, looking west.*

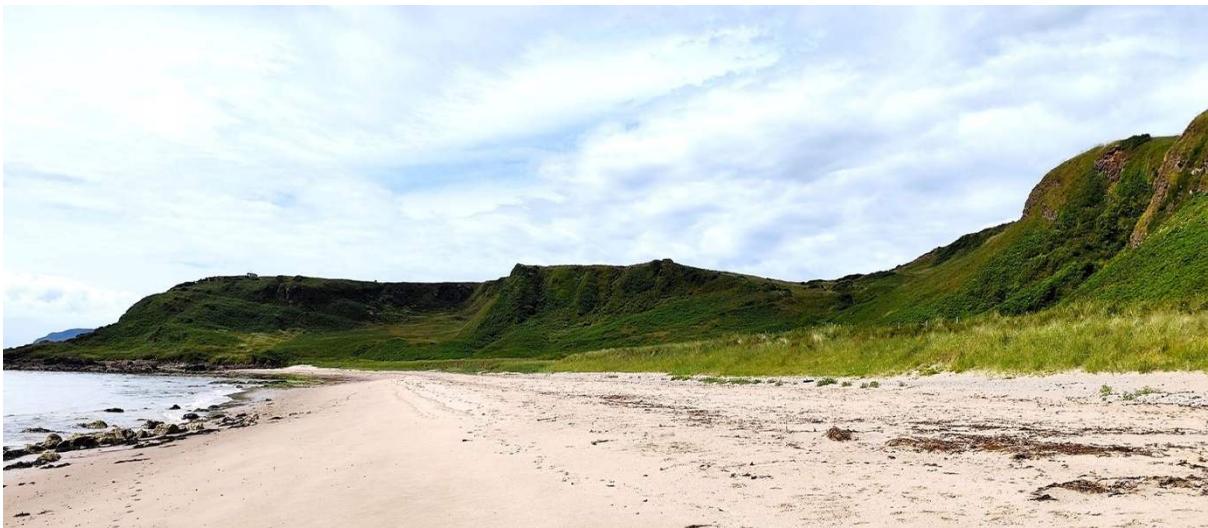
Travelling eastwards, the sandy beach between the Rubha MacShannaich and Dun Dubh headlands becomes narrower and is backed not with dunes but by a narrow section of raised beach and fossil cliffs (Figure 7). These appeared generally stable, with no

discernible consistent change in the position of the coast edge, although ad hoc rock armour has been tipped over one stretch of soft coast below Coledrain Farm. This would indicate episodic erosion here, even though the coast edge was vegetated and stable at the time of the survey (Figure 8).

Figure 7. Beach backed by low raised beach and fossil cliffs looking towards Rubha MacShannaich.

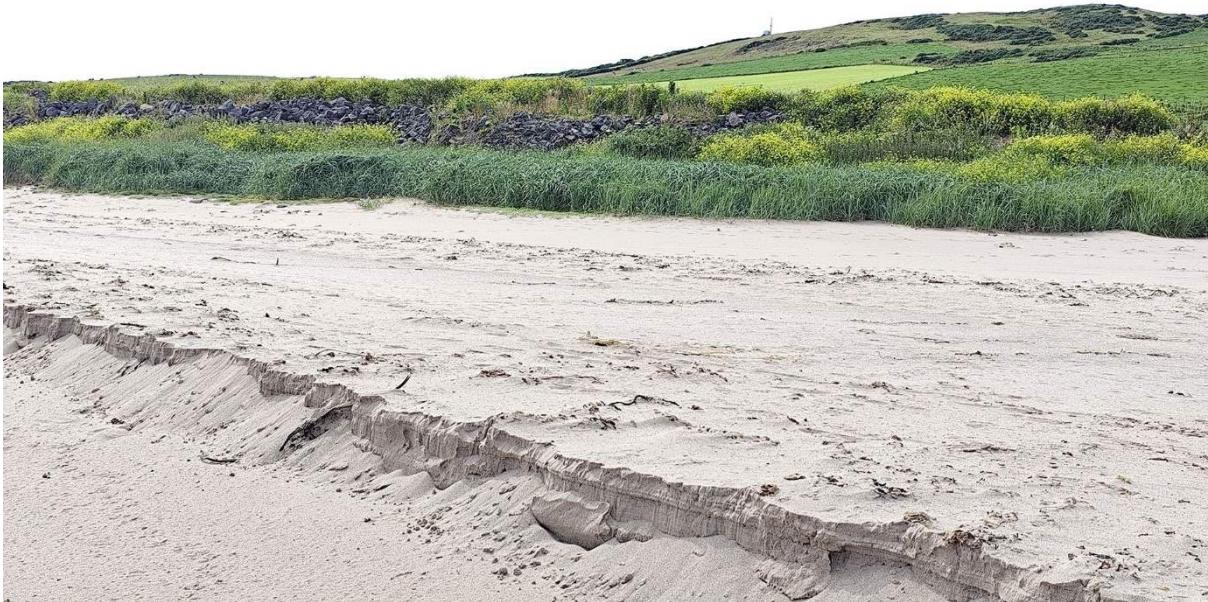
Figure 8. Ad hoc rock armour at the coast edge below Coledrain Farm. There is an erosional step in beach sediment in the foreground.

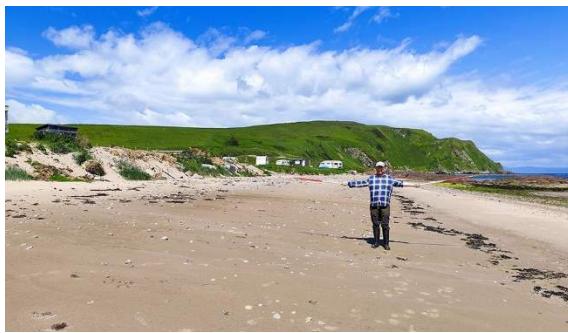
Further east at Macharioch Bay and Polliwilline Bay, the sand becomes thinner punctuated by rocky outcrops and areas of shingle (Figure 9 & Figure 10). We observed a landward migration of the MHWS in both bays in the order of 10m-18m with corresponding erosion of the low-lying soft coast backing the beach. There are ongoing attempts to stabilise the coast edge in front of the small caravan site at Polliwilline Bay.

Figure 9. Figure standing on the position of the MHWS in circa 1900 at Polliwilline Bay.

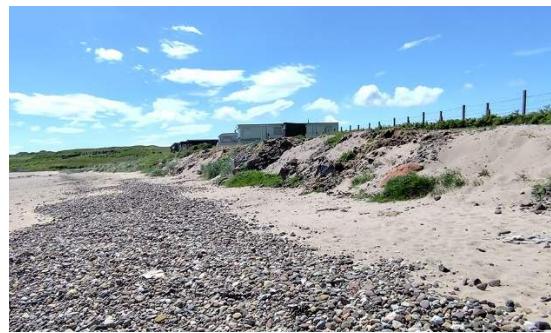
Figure 10. Ad hoc coastal stabilisation at Polliwilline Bay.

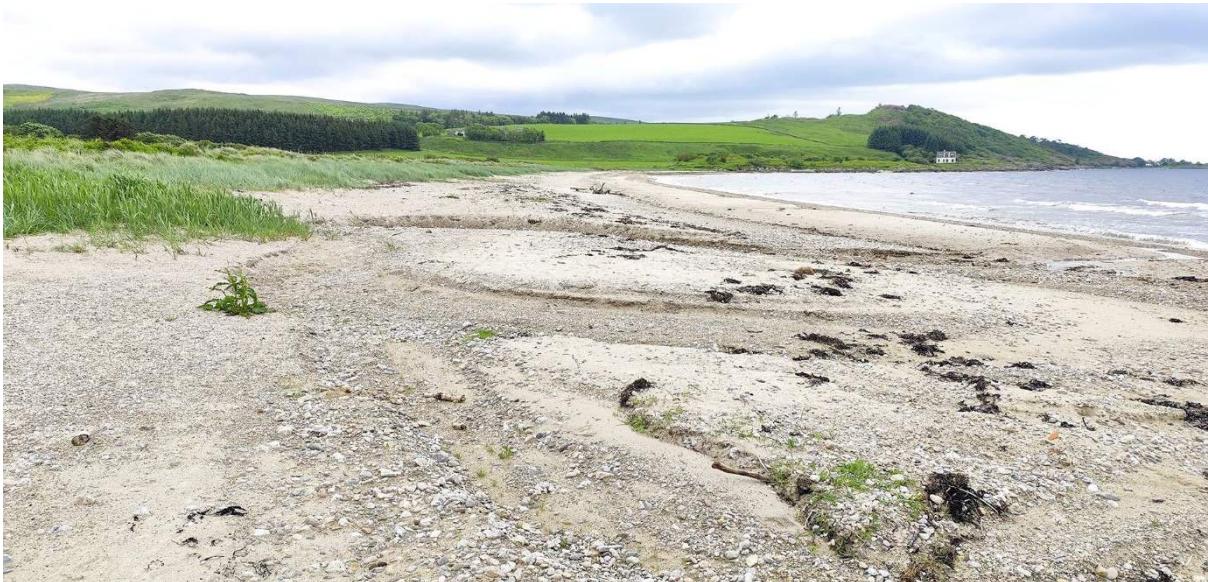
The small sandy bay at Dunskeig (Figure 11) is located at the west end of West Loch Tarbert as it opens into the sea. Dynamic Coast models significant future erosion here under a High Emission Scenario, although in 2000 no erosion was noted during research for the Coastal Cells in Scotland Series (Ramsay & Brampton 2000). We observed a migration of up to 10m landwards of the MHWS since circa 1900 in the north end of the bay and an accretion of around 5m towards the south end of the bay. A mid-19th century gun platform located in the northern end of the bay is the only known heritage asset that is at risk.

Figure 11. The southern end of Dunskeig Bay where slight accretion is occurring.

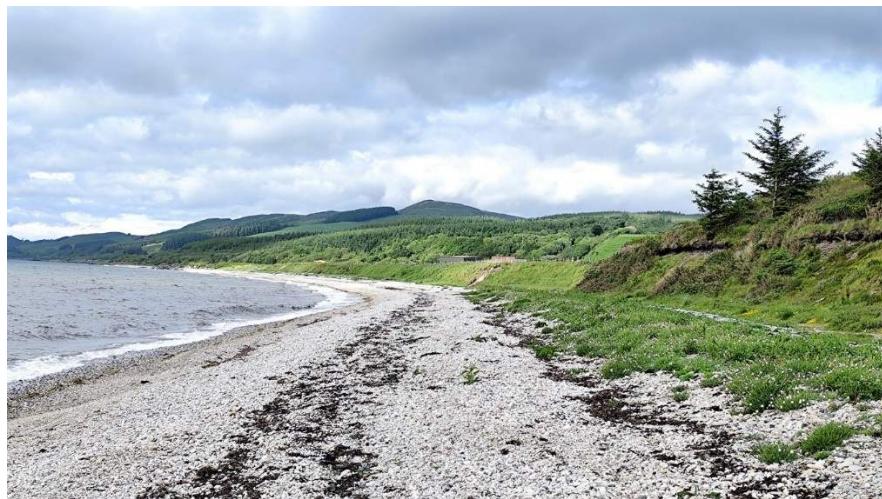
Between Dunskeig Bay and Tayinloan most of this long stretch of coast (Figure 12) is composed of shingle beach which Ramsay & Brampton (2000) recorded as well vegetated and stable but containing evidence of frontal erosion of the sand and shingle ridge backing the beach indicating that this coast can be extremely dynamic under north westerly storm conditions. We observed a similar picture during the field survey, but there are few known heritage assets behind the ridge that would be affected.

*Figure 12. The long stretch of shingle beach backed by a sand and shingle ridge, photo taken in front of the former fish farm, looking north.*

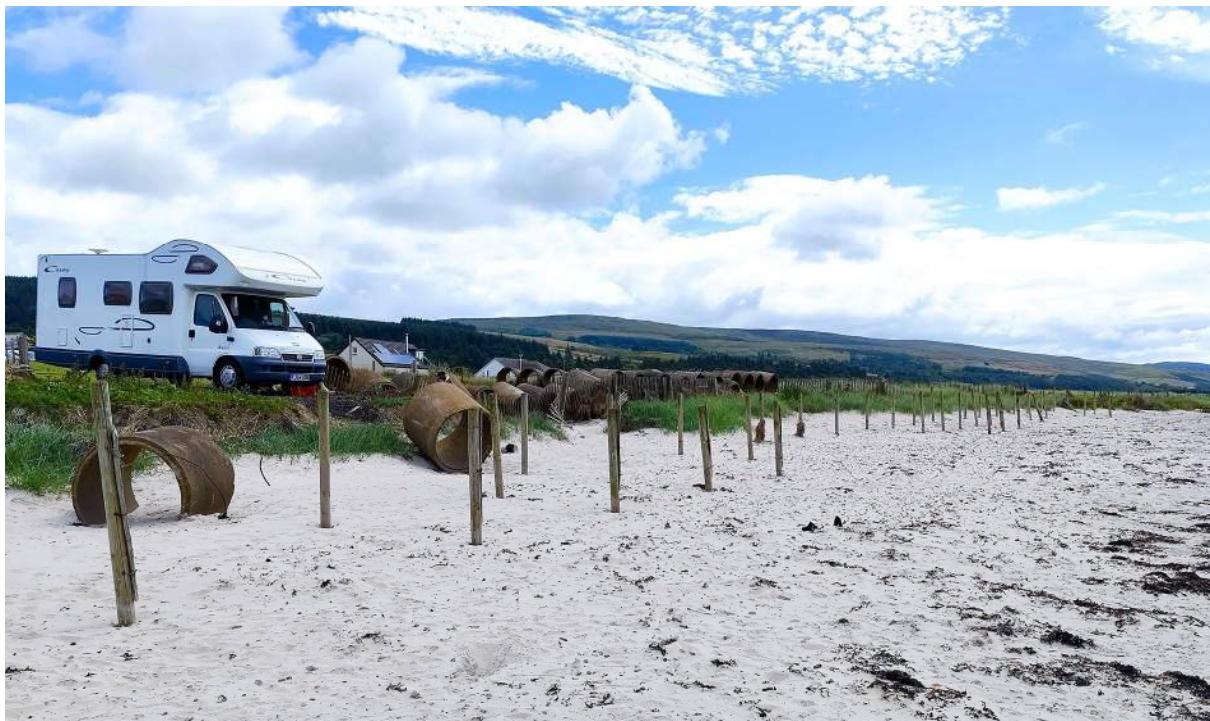
Figure 13. Fencing and old concrete pipes are struggling to consolidate sand built up here since the 1960s adjacent to the Tayinloan ferry terminal.

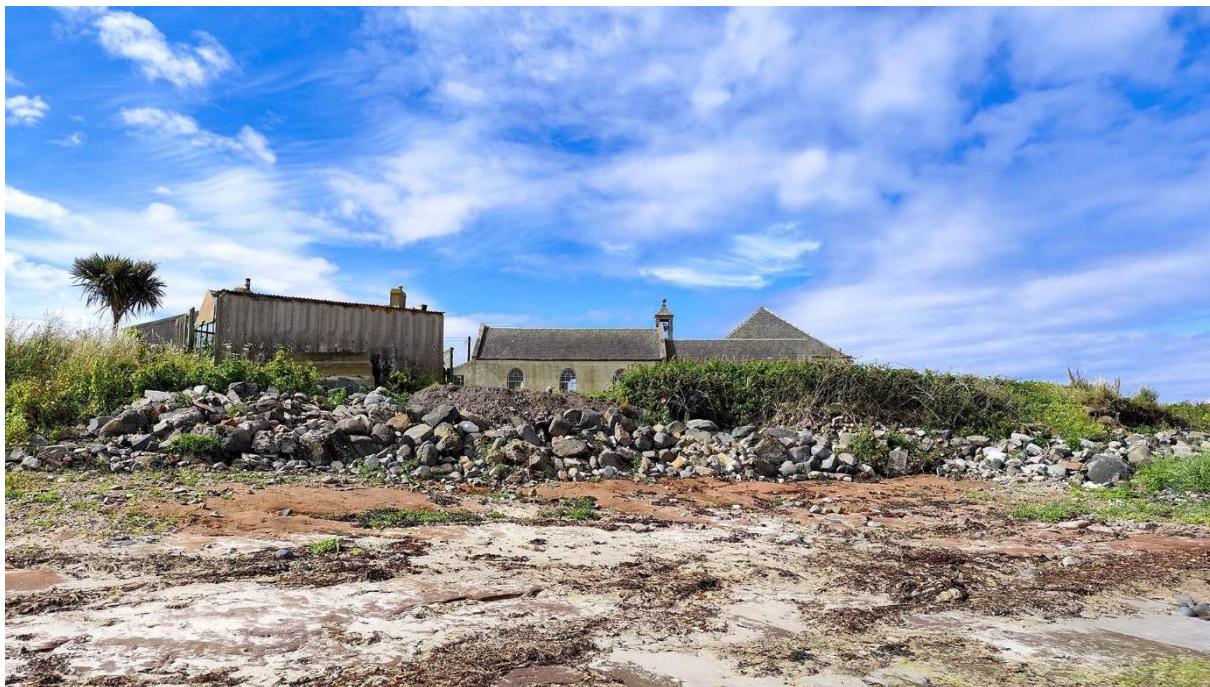
Figure 14. An erosion bite on the north side of A' Chleit church.

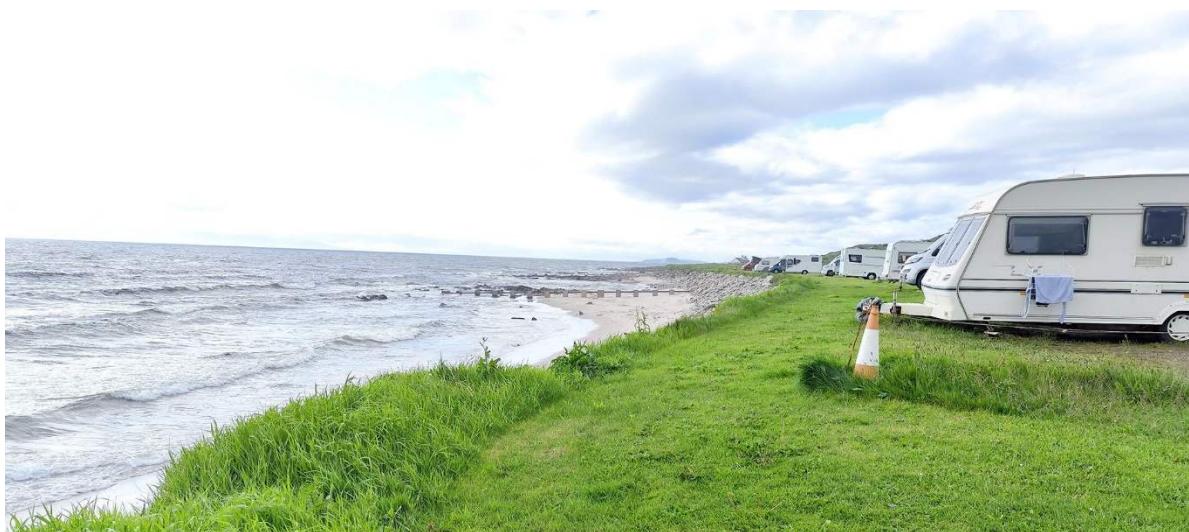
South of Dalkeith, erosion is affecting the soft low-lying coast edge in places, parts of which are protected by rock armour (Figure 15). The position of the MHWS and the coast edge along this narrow beach has migrated landward by 15-30m between Dalkeith and Bellochantuy since circa 1900 and this is the longest stretch of net erosion encountered during the survey.

Figure 15. Rock armour protecting the soft coast edge of the caravan park south of Dalkeith.

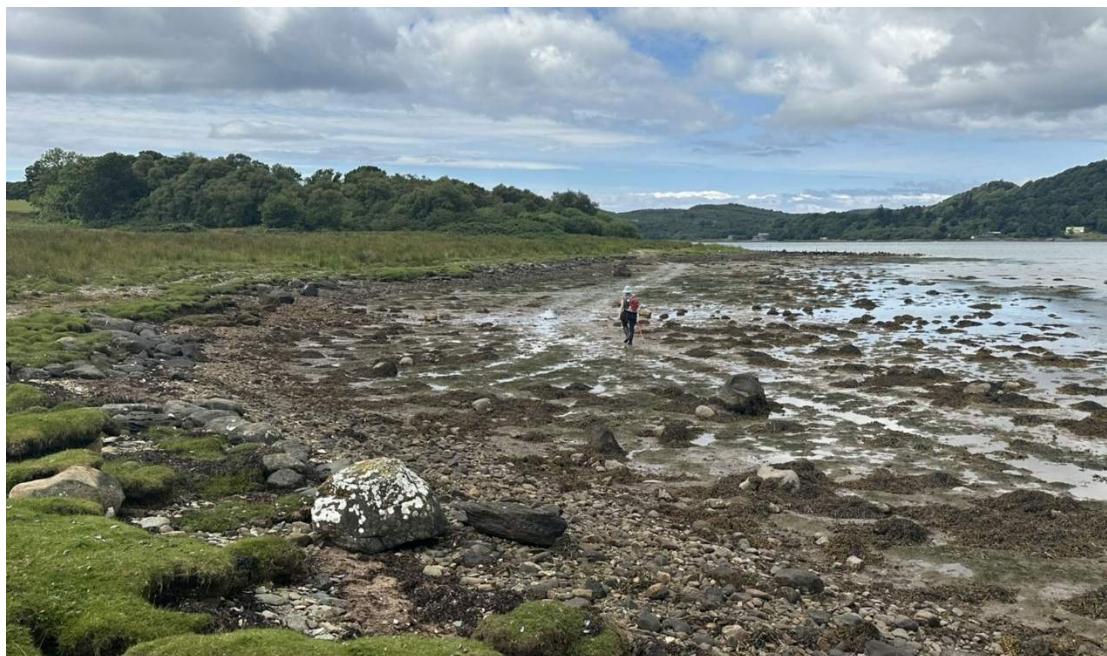
In this quiet low energy environment, the route of intertidal tracks remain visible over many tidal cycles and in low lying sections the shore merges with the land (Figure 16 & Figure 17).

Figure 16. Tracks of farm traffic preserved in the foreshore.

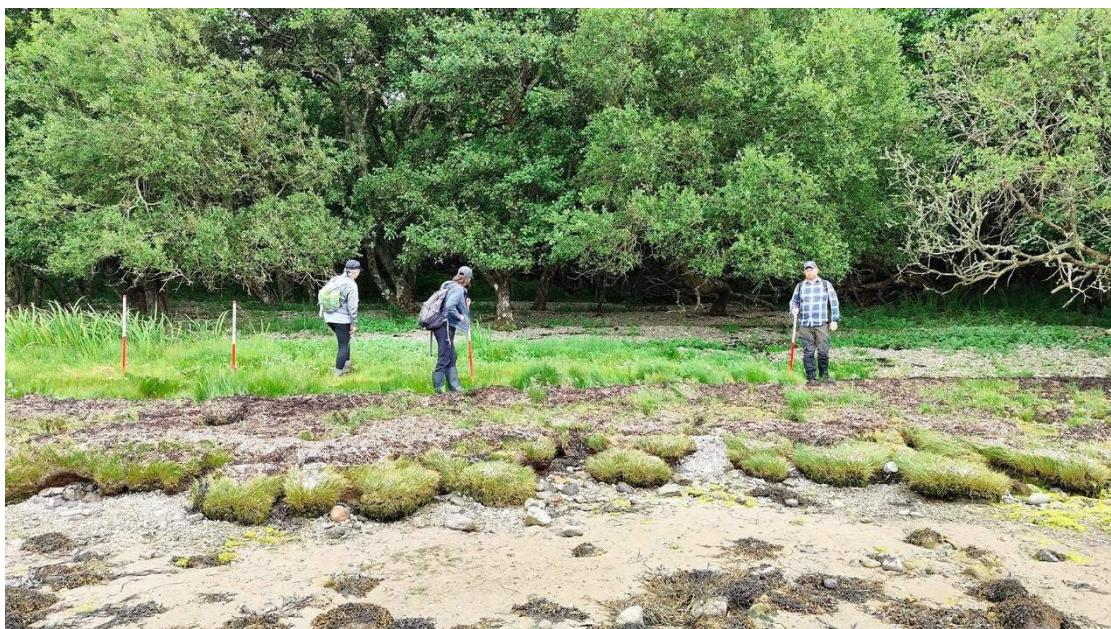
Figure 17. Beach sediments merge with woodland towards the west end of West Loch Tarbert.

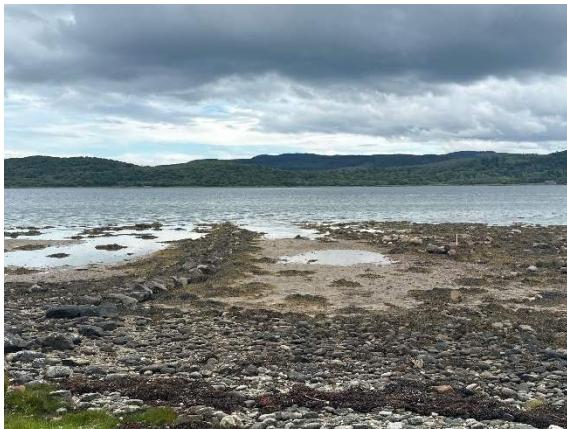
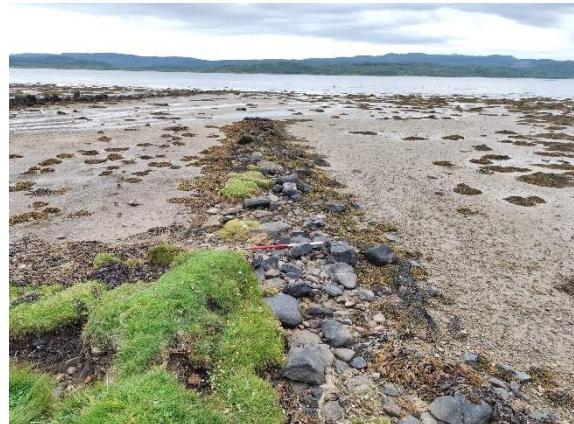
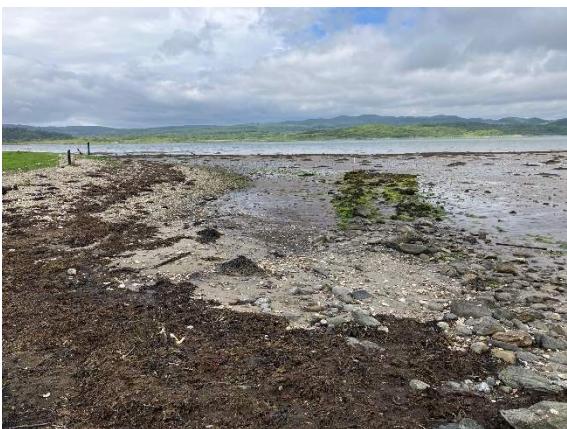
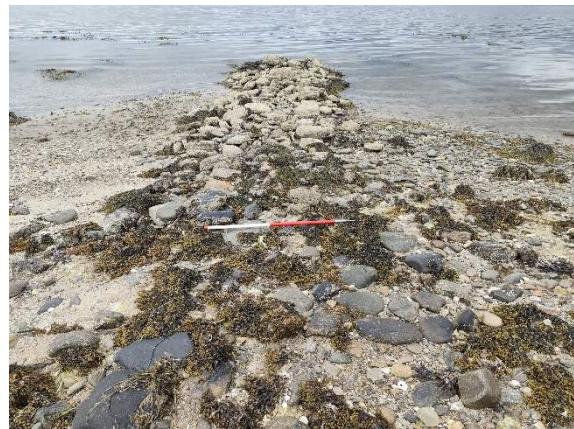
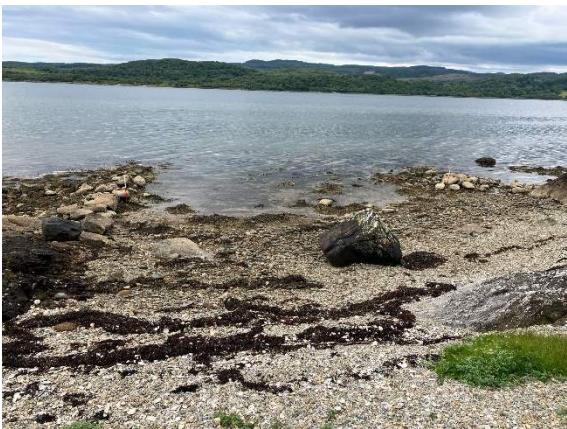
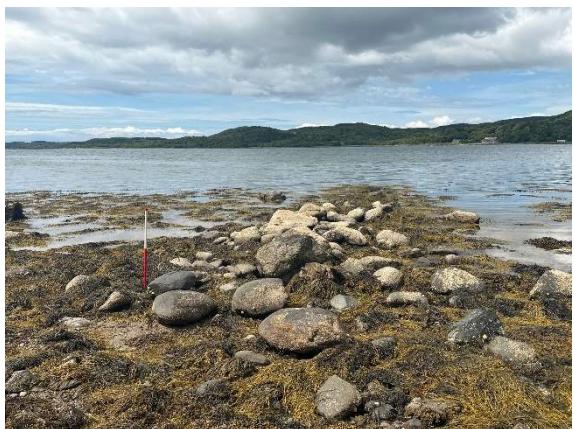
The use of the coast of Kintyre for maritime trade and transport is reflected in the number of harbours, cleared slipways and jetties that were discovered during the survey (Figure 20). Coal was a main import into the area, primarily for domestic use, and also for the burning of limestone for agricultural use, as noted in the Old and New Statistical Accounts of the Parish (Gordon 1999; Sinclair 1999). This is illustrated in the many Coal Depots and Coal Yards marked on the first and second edition Ordnance Survey maps of 1873 and 1899 and recorded, at Kilchamaig (SCAPE ID: 16980), Ronachan (SCAPE ID: 16992) and Killean (SCAPE ID: 16917). The export of agricultural produce, and in particular of potatoes, was also an important element of maritime trade in Kintyre. According to Martin (1987, 43) up to 3,175 tonnes of potatoes were exported annually in the 1840's, with Ireland being the primary market at this time. The frequency of jetties and cleared slipways discovered along the coast reflects this important economic activity.

Twelve landing places were recorded between the Portachoillan and Kilchamaig ferries. Of these, seven are jetties (SCAPE ID: 16924, 16926, 16927, 16933, 16935, 16968, 16987) each of which was defined by linear arrangements of stone extending into the intertidal zone. The remaining five sites are cleared slipways (SCAPE ID: 16930, 16931, 16985, 16983, 16830). A notable well-preserved example lies on the southern edge of Gartnagrenach Bay (SCAPE ID: 16830) which is defined by two parallel linear arrangements of stone and rocks up to 1m in width, positioned to the north and south, spanning an area 5m in width and extending 40m from the shoreline into the intertidal zone. A similar site was recorded on the northern edge of a small bay below Leamnamuic Farm. This site (SCAPE ID: 16983) is defined by a linear arrangement of boulders and stones 15m in length on the south side with a small circular concentration of stones on the north side of a cleared area, 4m in width. This site also utilises the natural bedrock outcrop that surrounds the bay to create a sheltered area in which to pull up boats.

Cleared Slipway SCAPE ID: 16983, Leamnamuic  
*Figure 20. Selection of Cleared Slipway's and Jetties at West Loch Tarbert*

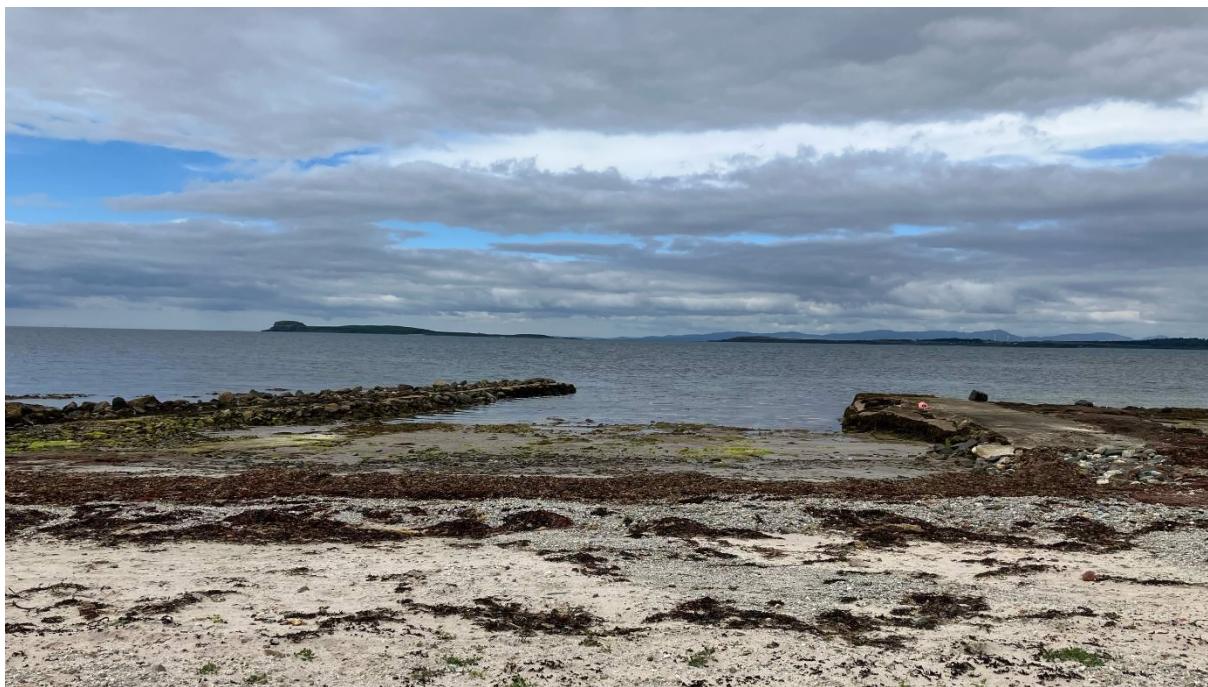
A more substantial and modern concrete harbour is located at Killean (SCAPE ID: 16826, Figure 21). The harbour is defined by two jetties, 20m apart. The 4m wide north jetty is made of poured concrete on top of the bedrock, while the narrower south wall combines large boulders and bedrock with a concrete overlay, each extending for approximately 30m from the shore. On the beach side of the south jetty, there is a curved concrete wall, and the north jetty features at least two mooring points. Additionally, there's an eroding patch of concrete in the middle of the slipway. The harbour is likely linked to the nearby Killean estate and was constructed after 1915, as it does not appear on the third edition Ordnance Survey map surveyed at that time, or on any earlier historic maps. A boat house (SCAPE ID:16917) is recorded here on the second edition Ordnance Survey map of 1899, all that survives of which is the concrete footings measuring 5.5m by 5m. This indicates that this area served as a landing place for the estate before the construction of the harbour.

*Figure 21. Killean Estate harbour (SCAPE ID: 16826)*

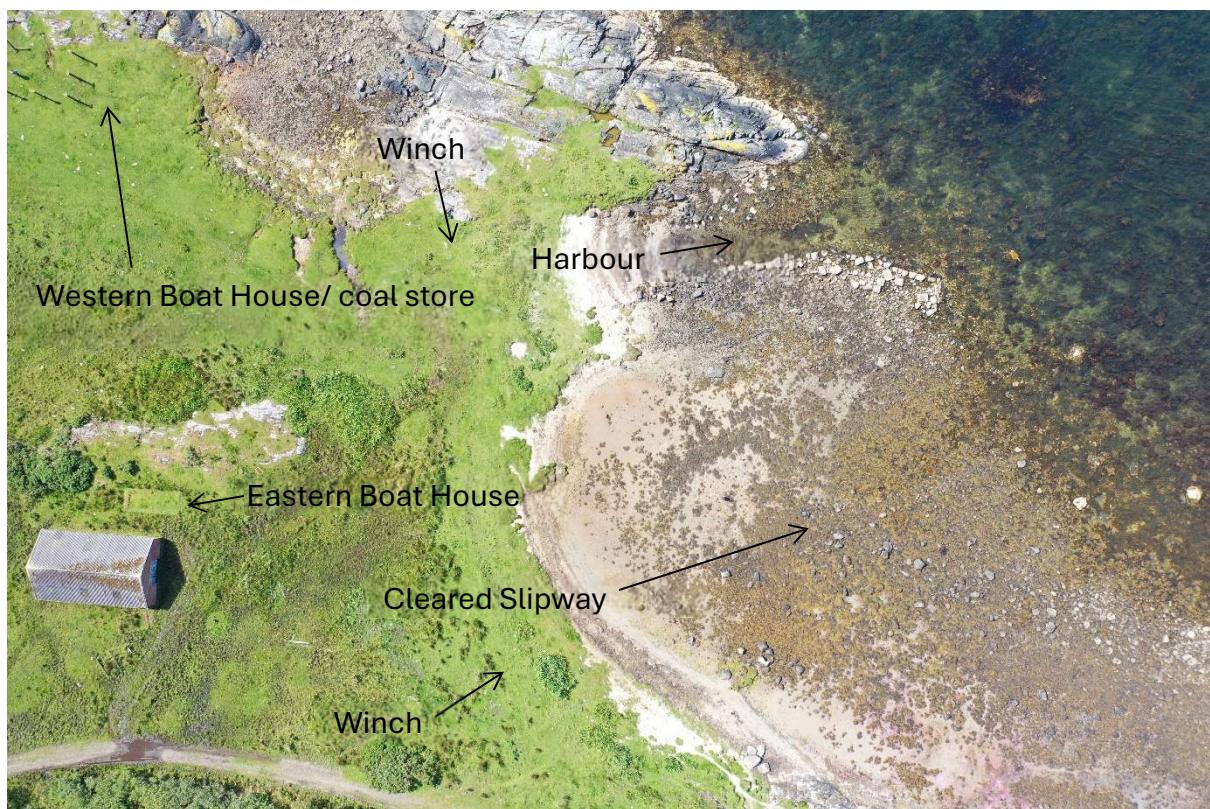
Figure 22. An aerial shot of the landing places and boat sheds at Dunskeig, with the iron plinths seen in the top left of the picture. North is to the right-hand side of the picture.

To the north of Dunskeig Bay is a landing area, referred to locally as the Coal Depot (SCAPE ID: 16993, Figure 22). Two boat houses are depicted here on the 2nd edition OS map of 1899 (Figure 23). All that remains of the western boat house (Figure 24), which is 13m by 5m in extent, are nine iron plinths (with one fallen on the northwestern side) each of which is 2m in height with ornately rounded tops, some of which have wood attached, secured in place with large iron pins. Slots on the sides of the plinths indicate that there would have been wooden slats making up the walls. Although mapped as a boat house, it is hard to see how the architectural form and location of the remains of the present building, with no easy access to the shore, would be suitable for this use. A coal store as suggested by local information is more likely. It is possible there was an earlier boat house in this location. The eastern boat house survives as a turf-covered rectangular foundation, measuring 6m by 2.5m in extent. A modern brick-built building, with an asbestos roof, is located 3m to the east of this boat house, measuring 15m by 10m, which is still in use as a storage shed. A harbour and cleared slipway are located in the bay around 50m to the north of the buildings. The harbour is defined by a coursed stone jetty on its east side which is tumbled in places and runs for around 25m from the shore into the intertidal zone. In the bay just to the east is a further cleared slipway with a much-tumbled alignment of stone on the east side. A winch, the concrete and stone base of a probable second winch, and two mooring rings set into a ridge of bedrock are located in the area between the harbour and bay and the buildings. This landing place lies close to a track that leads from the Portachoillan Ferry to Clachan and may be associated with this township.

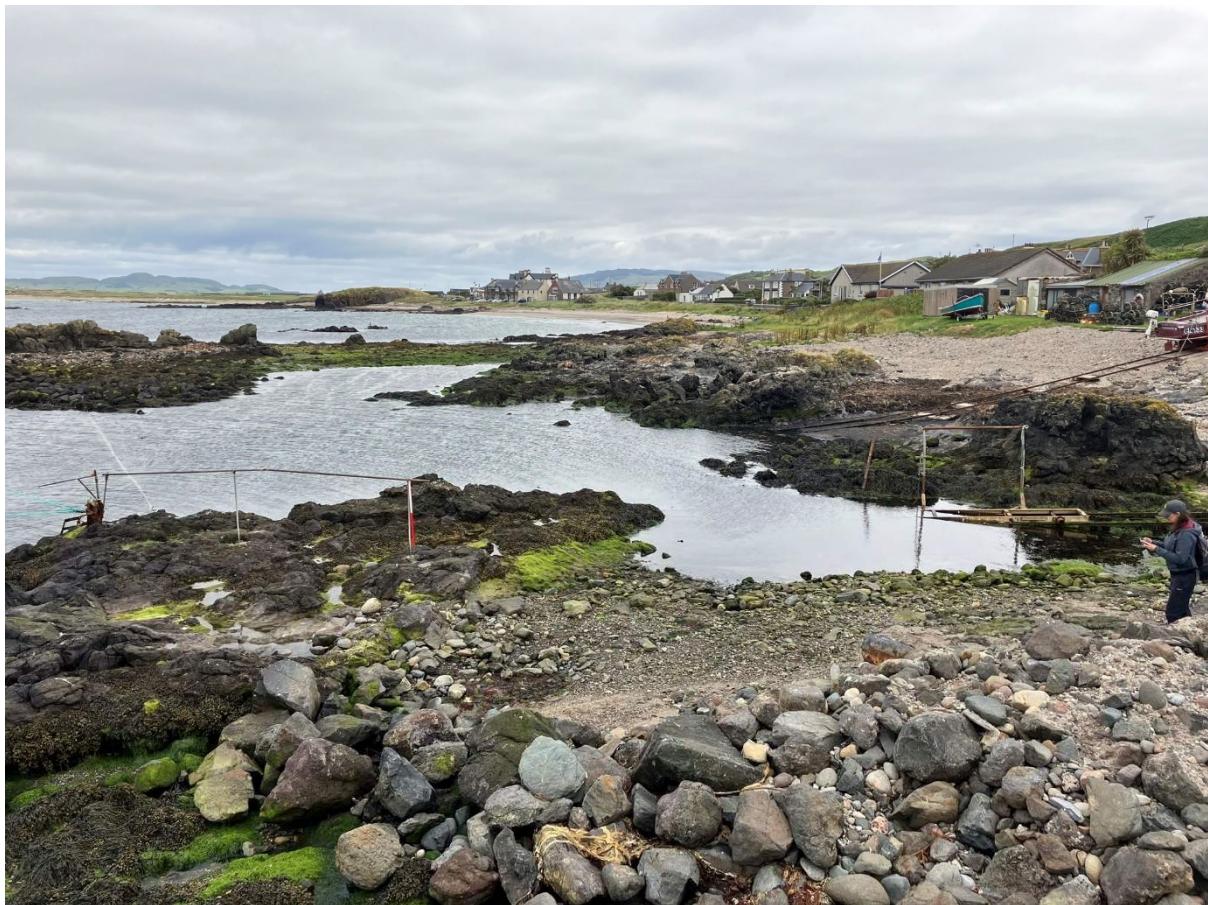
At Machrihanish a group of slipways and moorings were recorded in the harbour (SCAPE ID: 16959, Figure 25) near the original area of Marypans, named after the salt pans, that once stood near here. The harbour is still in use with two slips used for small fishing boats, with metal rails leading down to the sea. These slips appear to utilise older cleared slipways while a larger cleared area lies to the east, which would have accommodated more or larger boats. There are several mooring rings around the harbour, some of which are still in use while others have been degraded or rusted into position. According to MacDonald (1982, 181) Marypans was often mentioned in the historical records of the 18th century as a place for landing goods and cattle from Ireland. To the east of this site and clustered around the Little Scone rock are several modern iron moorings (SCAPE ID:

16960), which local volunteers said were in use until recently for lobster boats. An older concrete jetty (SCAPE ID: 16999) is located on the eastern side of the bay, on the Carack Caban rock, which is first marked on the second edition Ordnance Survey map of 1899.

Figure 25. The harbour at Machrihanish looking east (SCAPE ID: 16959)

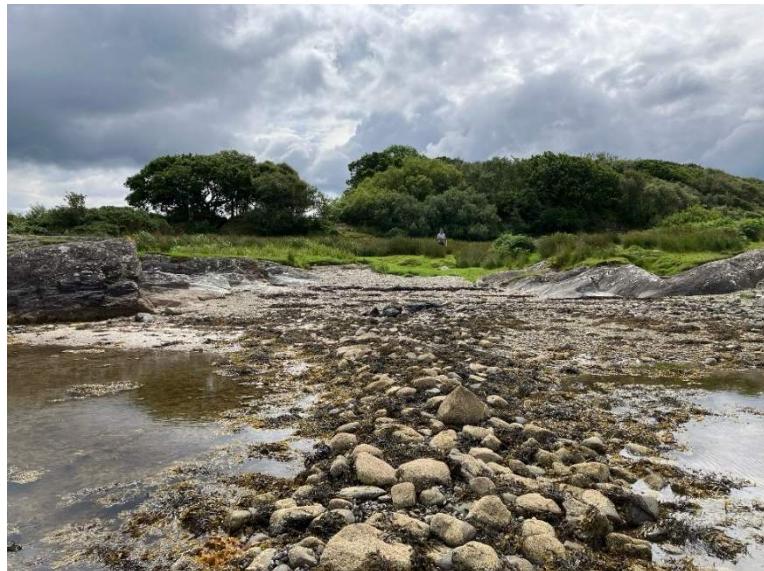
The Kilchamaig ferry site (SCAPE ID: 16980, Figure 26) survives as a ruinous stone-built jetty with an associated cleared slipway within a small natural harbour. The jetty survives as a collection of rounded stones and boulders spread to 2.5m in width and 30m in length.

Iron mooring fittings were pointed out by the local farmer and landowner Mr Mundell and can be seen attached to the rock on either side of the bay. The remains of a track can be seen leading away from the shore in the direction of a building, the base of which is all that remains, which was depicted on the 2nd edition OS map of 1899, as a coal depot but latterly used as a boat shed by the farmer.

Figure 26. Kilchamaig Ferry Harbour (SCAPE ID: 16980)

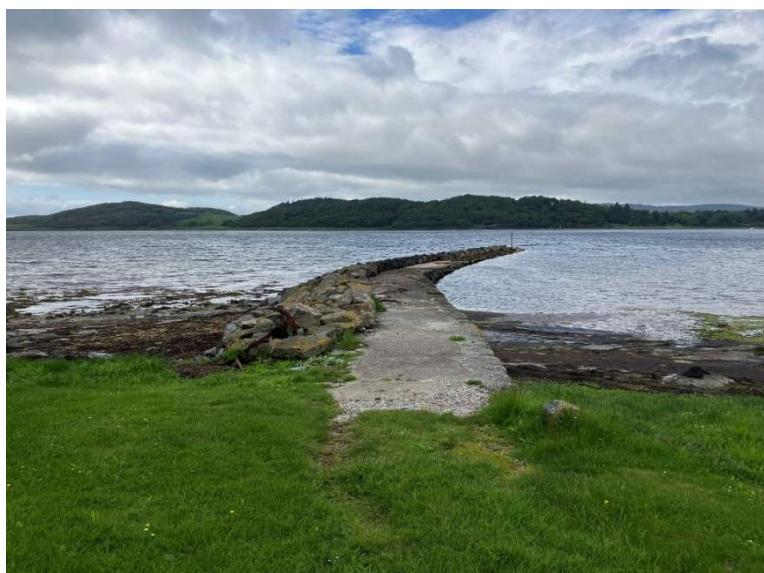
The ephemeral nature of this site is in contrast to the ferry jetty at Portachoillan (SCAPE ID: 16825, Figure 27) which, while surviving in use for a longer period of time, was also the main harbour for the nearby settlement of Clachan, and therefore possibly required more permanent infrastructure. The jetty is labelled as a "quay" on the first edition OS map of 1873 and though there may have been an earlier structure at this site, this jetty probably dates to the 19th century. The jetty, which is approximately 90m in length, survives as a combination of concrete and rocks with the central walkway capped with concrete, while the south side is enhanced and protected by large rocks.

Figure 27. Portachoillan Ferry jetty (SCAPE ID: 16825)

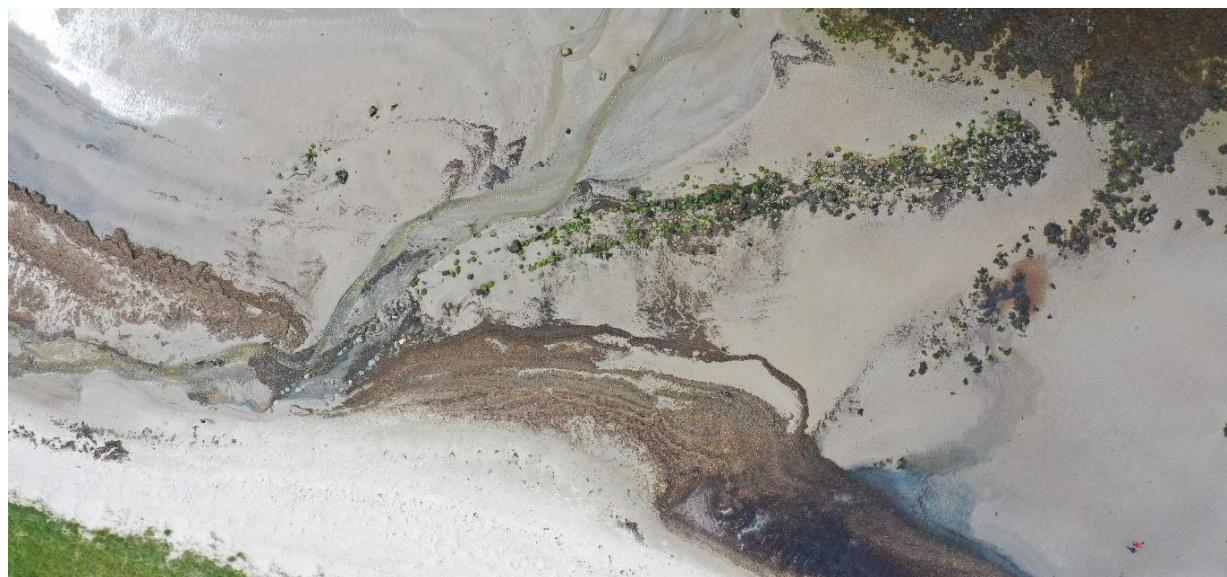
None of these accounts make any mention of one of the most substantial intertidal features that we encountered, located 400 metres south of the current Tayinloan ferry terminal site (SCAPE ID: 16821, Figure 29). The structure measures 3-4m in width and extends for approximately 74m in a crescent from southeast to northwest. The foundations of the structure are defined by a kerb of boulders filled with smaller stones. A prominent upright boulder at the terminal end likely served as a mooring post. While not annotated on any historic maps there is a curving line of stones depicted on the first edition OS map of 1873, in the location of the site, suggesting that it was ruinous by this time.

Figure 29. Possible quay at Tayinloan (SCAPE ID: 16821)

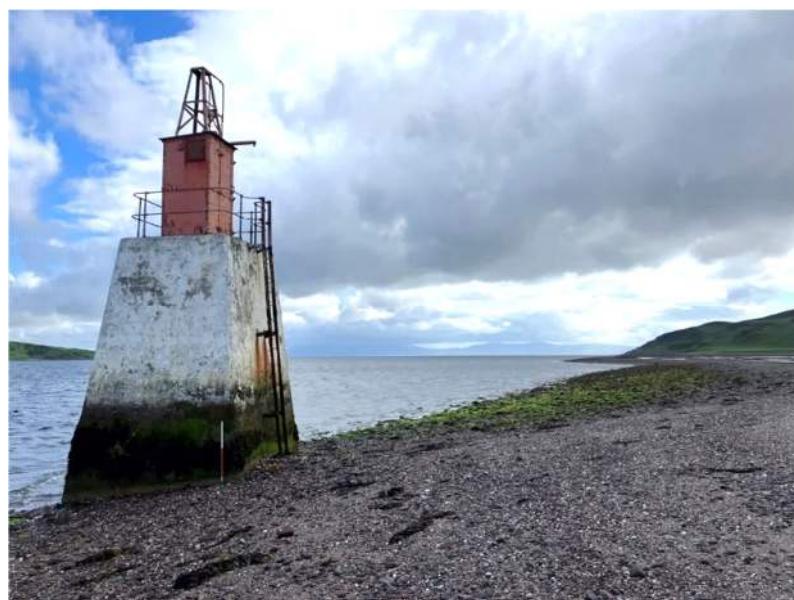
Campbeltown Loch is one of Argyll's busiest harbours and historically was an important transport hub for several industries including the Campbeltown distilleries, fishing, shipbuilding and more recently naval operations. The entrance to the loch is shielded from the south by Island Davaar, which is a tidal island that can be reached across a shingle sand bar, known as the Doirlinn. To aid safe navigation a beacon was constructed at the northern end of the sand bar, which was first depicted on the first edition Ordnance Survey map of 1869. The current beacon is of more recent date, but occupies the same position, and is constructed of iron and stone (SCAPE ID: 16822, Figure 30). Some of the fittings, such as the ladder and top railings are slightly rusting, but it is in a good state of preservation overall. A corresponding beacon lies just off Trench Point on the north side of the loch (CANMORE ID: 305468).

Figure 30. Beacon (SCAPE ID: 16822) on the Doirlinn looking towards the Clyde Estuary to the East.

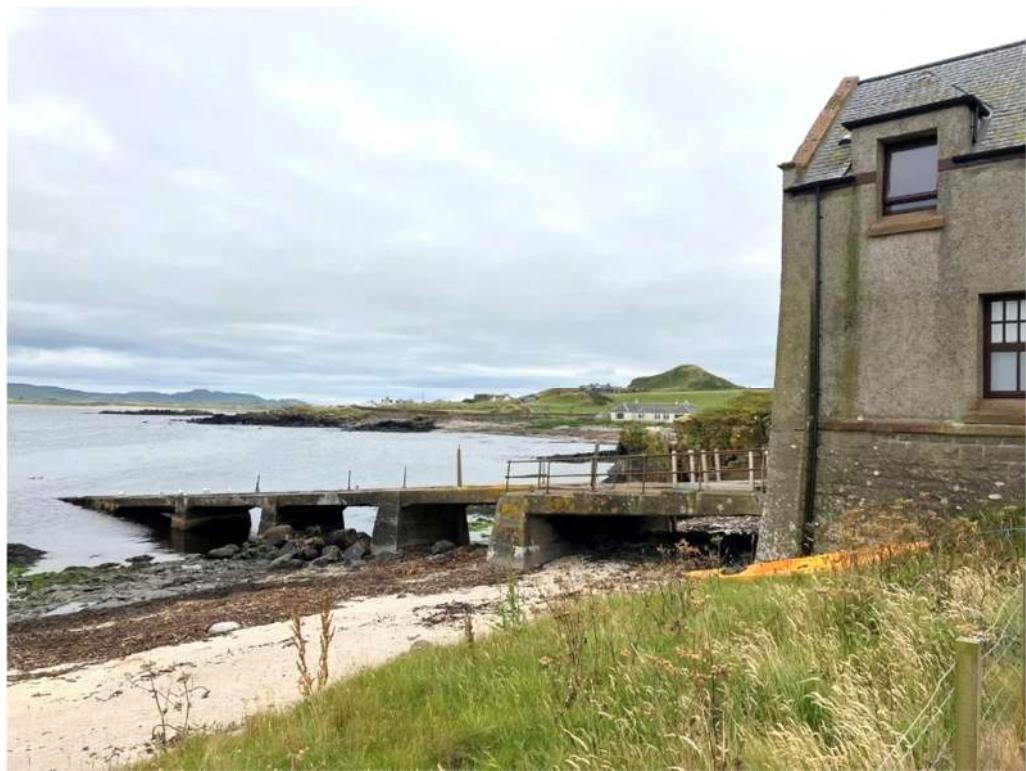
West of Machrihanish at Uisaed, is the short-lived Machrihanish lifeboat station built in 1911 and closed in 1930. The original prefabricated slipway survives intact and has not been renovated, but it is showing signs of weathering and erosion and is no longer safe to walk on. The Henry Finlay lifeboat, oar and sail propulsion, built at Bow Creek, Blackwall, London was stationed here until the closure of the station (local information). This site was converted into a marine research lab by the University of Stirling in the 1990s, and while few original interior features remain, the exterior largely retains its original appearance (SCAPE ID: 17000, Figure 31 & Figure 32).

Figure 31. Uisaed Machrihanish lifeboat station looking east (SCAPE ID: 17000)

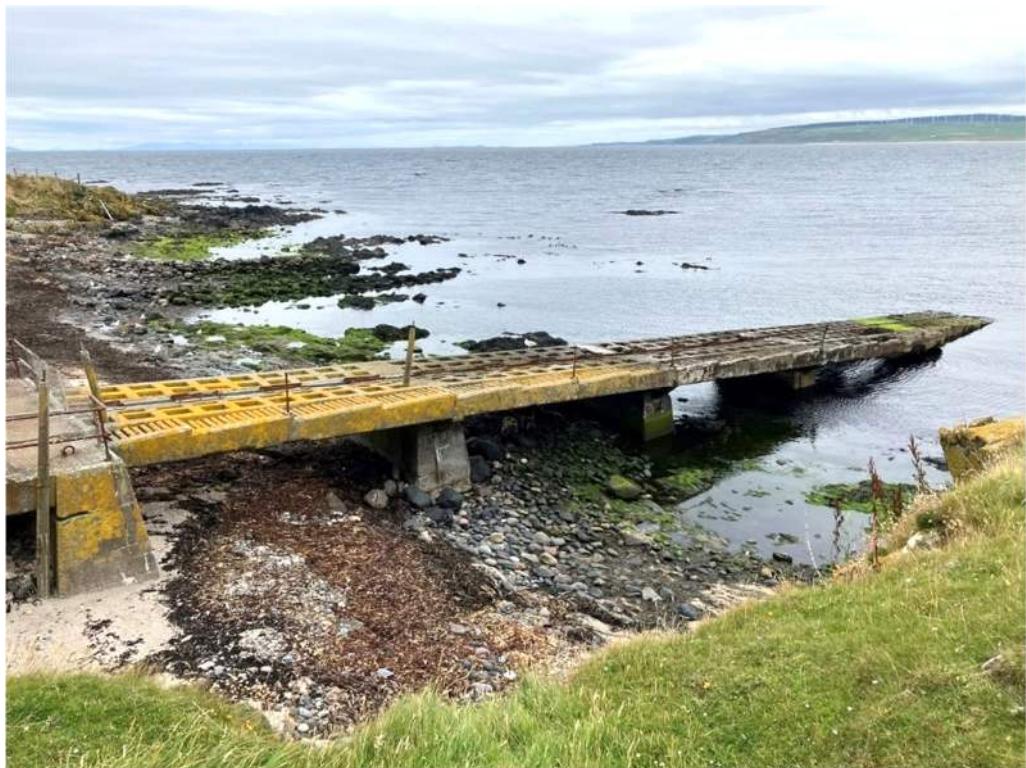
Figure 32. Uisaed Machrihanish lifeboat station slip looking west (SCAPE ID: 17000)
