Scottish Coastal Archaeology and the Problem of Erosion

# Coastal Zone Assessment Survey

## Kintyre

The SCAPE Trust and the University of St Andrews  
November 2024

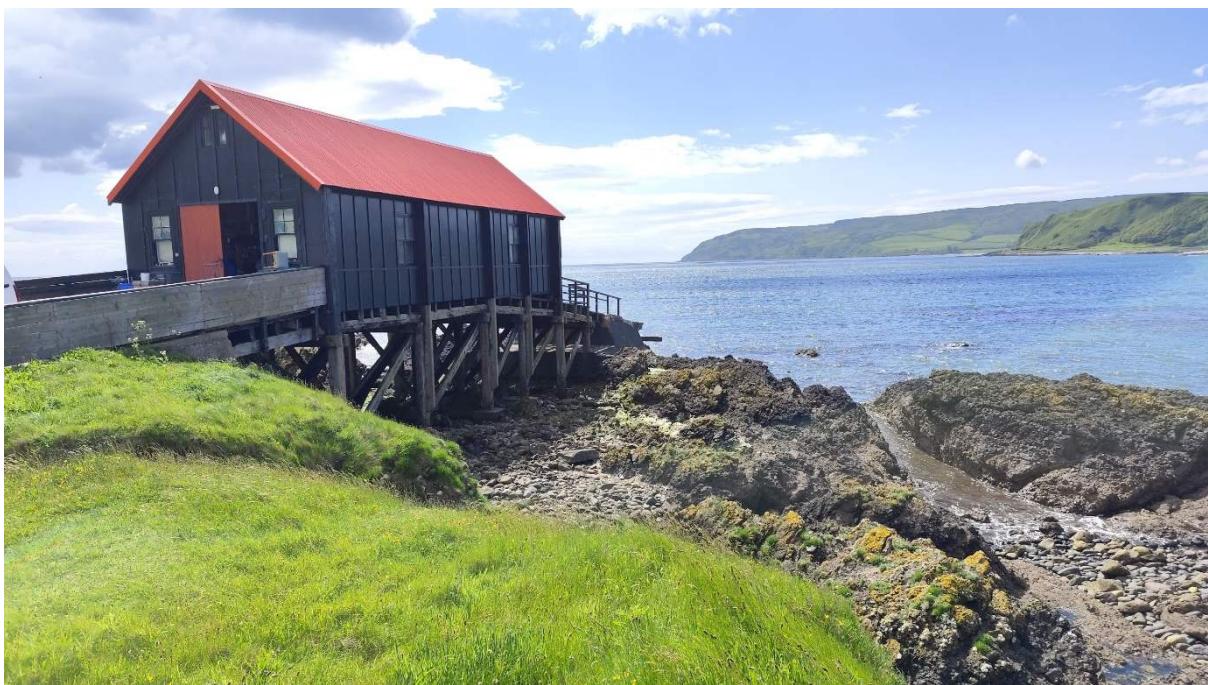
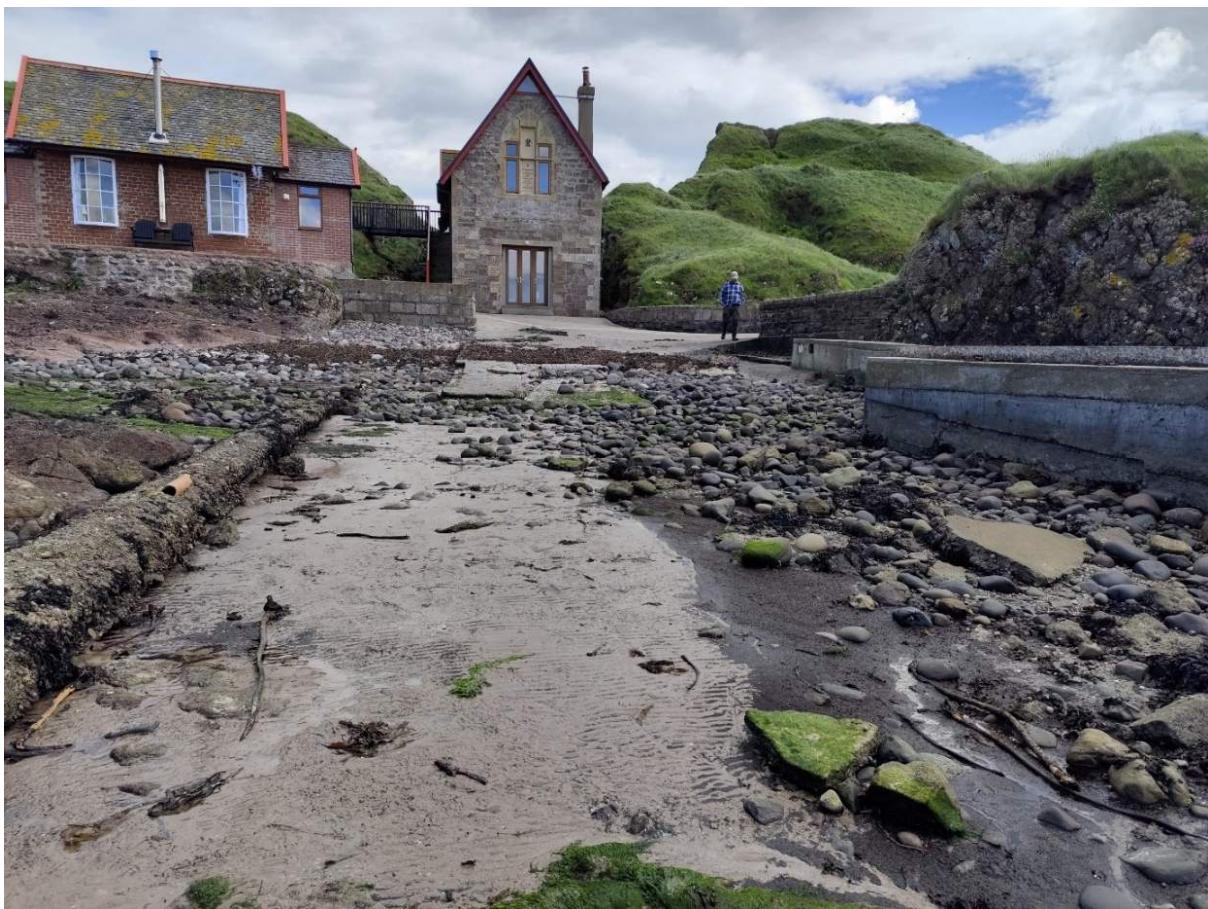
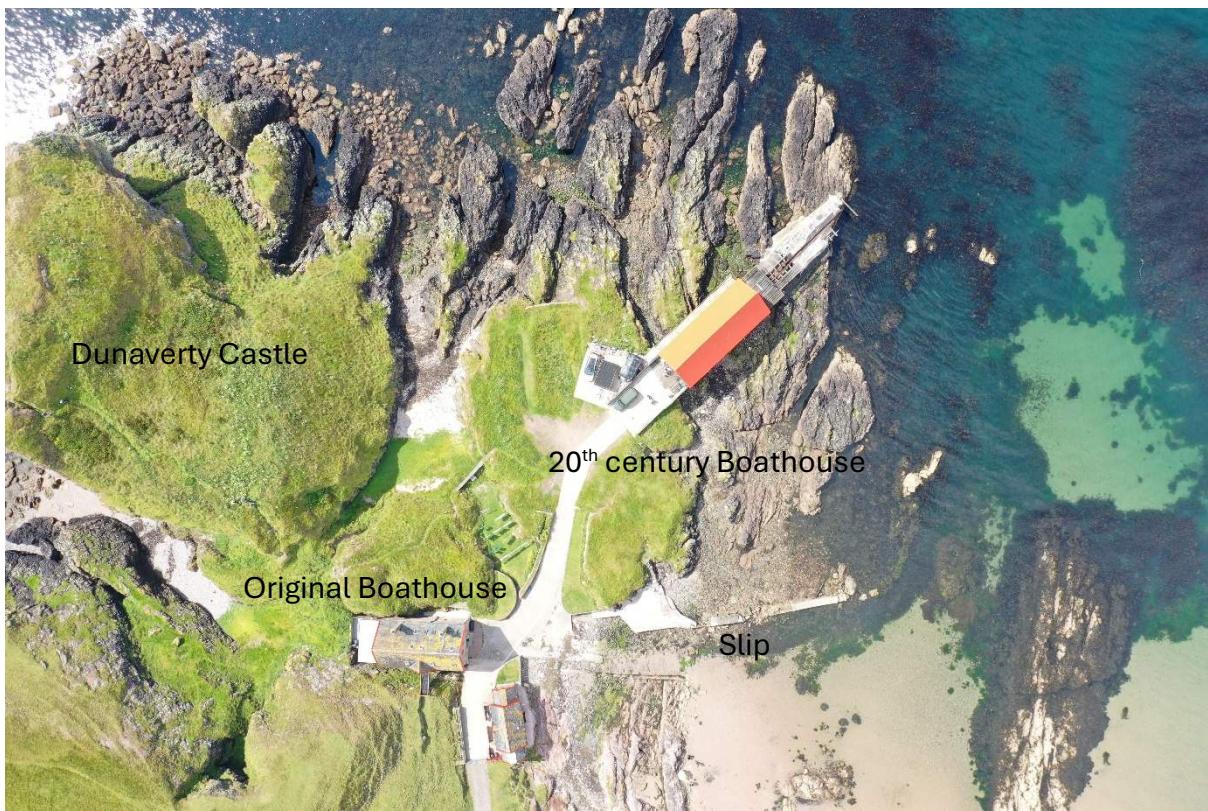
The Dunaverty lifeboat station (SCAPE ID: 16806 & 16814; Figure 33, Figure 34 & Figure 35) was established in 1869, with several original elements surviving, such as a two-story lifeboat house. This building housed the boat on the ground floor and provided accommodation for the coxswain and his family upstairs. In 1904-05, a second boathouse and concrete slipway were built to accommodate a larger lifeboat, with the original house being converted into a winch house. The second boathouse was demolished in the mid-20th century but has recently been replaced with a modern building. This modern building, the original stone-built boathouse and the ancillary buildings have recently been converted into private houses, but many of the original features survive and are well preserved. Several other elements of the lifeboat station survive around the site, including an original slipway, which according to Leach (2013) pre-dates the lifeboat station and was used to transport stone to offshore craft, while a winch is also preserved at the side of the original house, though this does not appear to be in situ.

Figure 33. Dunaverty lifeboat station and boathouse looking west (SCAPE ID: 16814)

Figure 34. Dunaverty lifeboat station looking east, with slip in foreground (SCAPE ID: 16806)

Figure 35. Aerial view of Dunaverty Lifeboat Station (SCAPE ID: 16806 & 16814) and Dunaverty Castle (SCAPE ID: 16762) to the top left.

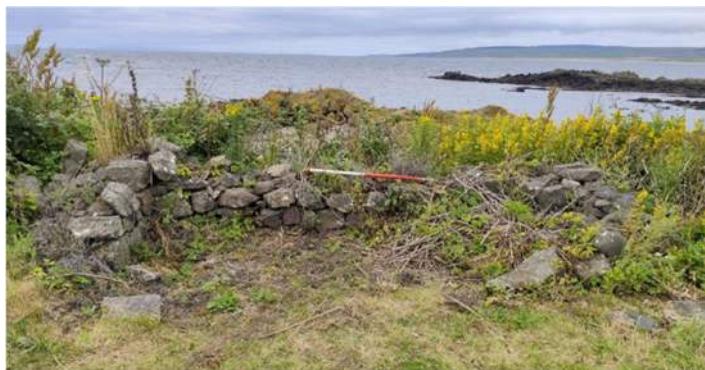
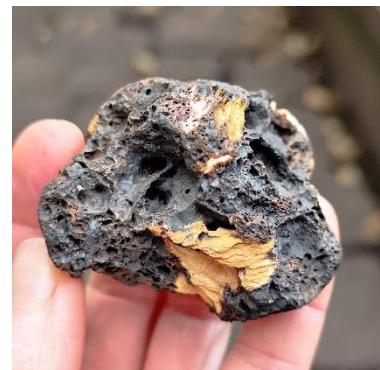
Figure 37. Possible building associated with saltpans (SCAPE ID: 16958) and piece of clinker found on shore.

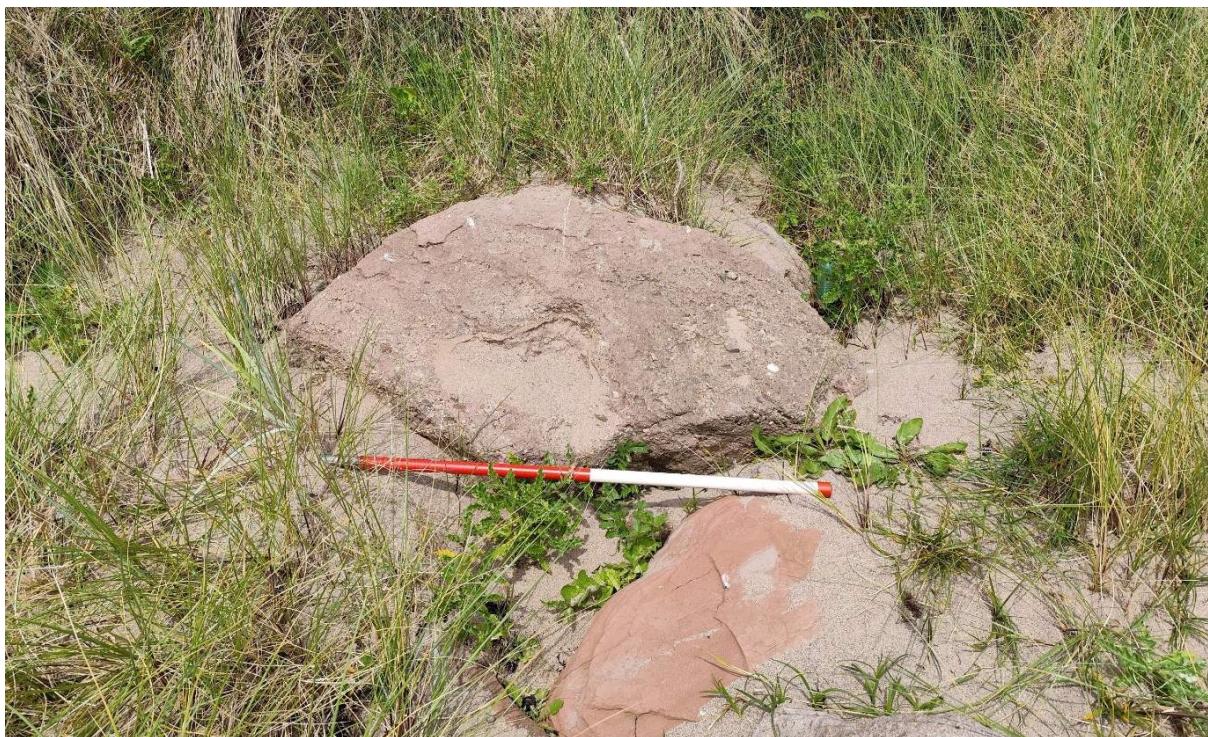
There is documentary evidence of a millstone quarry at the southern tip of Kintyre in the general area below Dun Duirn at the eastern end of Brunerican Bay operating in the 18th and 19th centuries. According to an article by Martin (2008, 27-28) based on an extract from "Southend Fifty Years Ago" published in the Argyllshire Herald in 1867 and reproduced in the Kintyre Magazine (no. 64, 2008) the stones were cut from the conglomerate outcrops on the beach and transported by horses to Machrimore meal mill 1.7 kilometres to the north. A broken rough-out of a millstone usually buried in sand is occasionally uncovered. We identified a further probable rough-out near the bottom of a graded trackway which runs from the beach up to the plateau above the shore (SCAPE ID: 16956, Figure 42). The current mill, which has been converted into a house, was built in 1839 under the terms of a new lease granted by the Duke of Argyll apparently to replace an earlier site.

Figure 42. Possible millstone roughout (SCAPE ID: 16956)

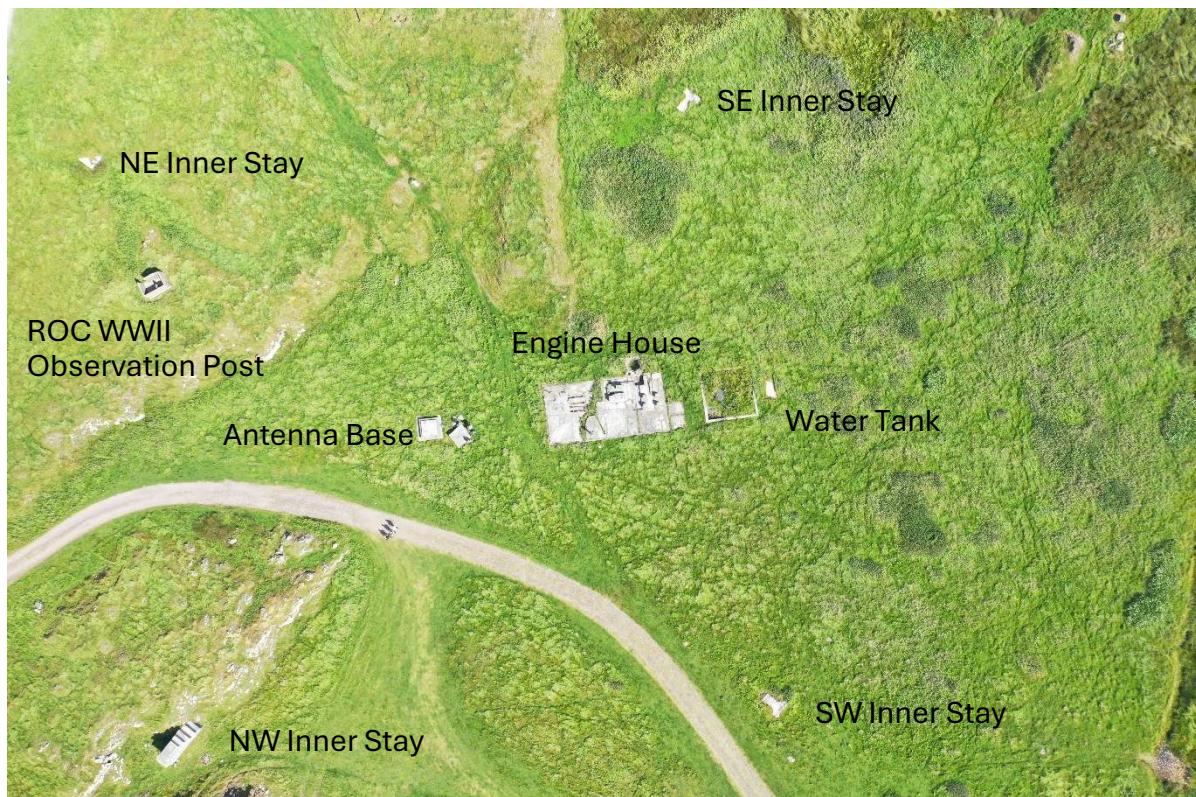
Unfortunately, the radio mast collapsed in a storm in December 1906 and was not rebuilt, but the site retains a number of significant features associated with its design and layout. These include concrete foundations relating to the base of the mast and antenna (Figure 44 & Figure 45), concrete anchor points for the mast mounting blocks for the boiler and steam engine that powered the station (Figure 46 & Figure 47), a water tank and the operator's shed that contained the equipment. The site is in a relatively good state of preservation, but remnants of the concrete antenna base are slowly deteriorating due to weathering, revealing its lower iron strata, though fragments of the ceramic resistors remain in place. Wooden components of the steam engine house are still in situ, although some of the concrete shows signs of decay. The site was recently recorded by Steve Birch (2021; 2022), of West Coast Archaeology Services, ahead of the expansion of the marine research facility, when he also carried out excavation and detailed recording of the remains of the engine house, alongside trial trench evaluation within the backfilled water tank. Several artefacts relating to the use of the site, including kitchen ware, bottles, and domestic items, were recovered as well as features relating to water management for the boiler and steam engine house.

Figure 43. Aerial view of Fessenden's Machrihanish Wireless Station (SCAPE ID: 16832)

We recommend the Wireless Station be assessed as a potential candidate for designation as a Scheduled Monument.

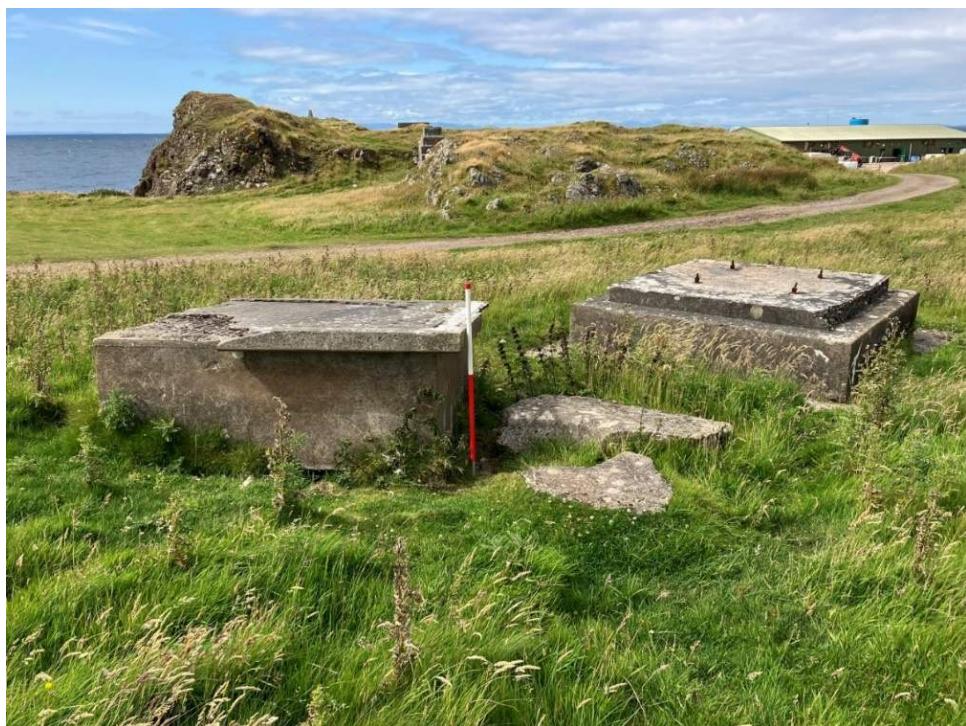
Figure 44. The concrete base of the mast at Fessenden's Machrihanish Wireless Station (SCAPE ID: 16832)

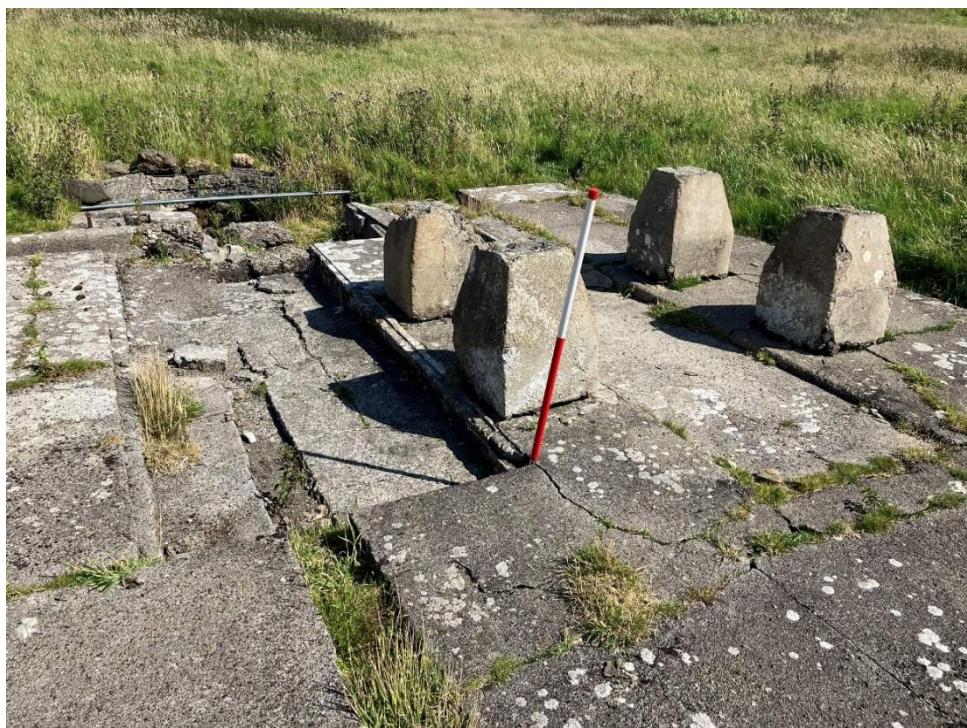
Figure 46. Foundations of steam engine used to power radio station (SCAPE ID: 16832)

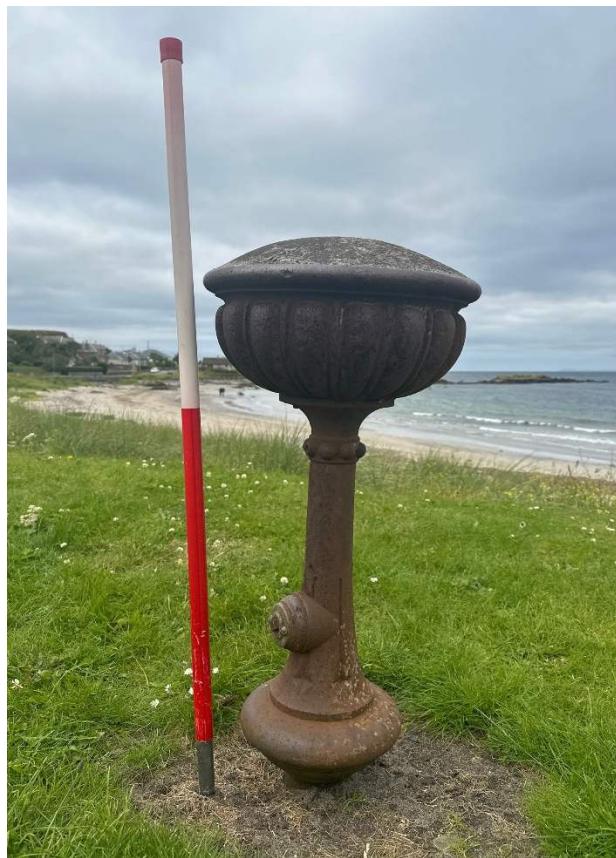
A little piece of historic infrastructure in the form of a cast iron water drinking fountain on the seafront at Machrihanish (SCAPE ID: 16961) is a reminder of the historical importance of the village as a popular tourist destination in the late 19<sup>th</sup> and early 20<sup>th</sup> centuries. This was made possible by the Campbeltown Machrihanish railway line, which took passengers from the boats in Campbeltown to the west coast. The line originated as the light coal railway constructed to take coal from mines in Drumlembie to Campbeltown in 1876 (The Road to Drumleman, 2017, 5). According to local information, the fountain was installed for passengers disembarking at the nearby station to walk down to the coast. Unfortunately, due to saltwater ingress, the fountain went out of use and has been filled with concrete.

Figure 49. Drinking fountain on the sea front at Machrihanish (SCAPE ID: 16961).

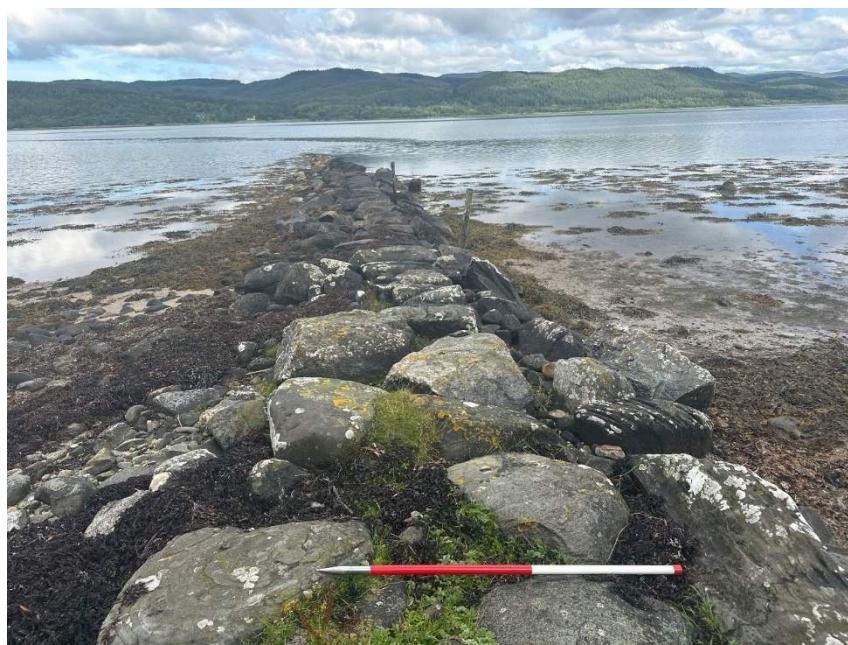
Settlement and agricultural boundaries were the second most common site type recorded during the survey, accounting for 28% of the new sites recorded. Of these, the majority were recorded in West Loch Tarbert and are associated with the historic farms and estates of the area. Kilchamaig farm at the northern end of the survey area, first appears in the record in 1481 when the Lords of the Isles received lands here (Thomson & Balfour 1984). Kilchamaig alongside settlements at Gartnagrenach, Leamnamuic, Loop and Ronachan all appear on Blaeu's Atlas of 1654, which is based on Pont's map, made between 1583-96 showing that these farms and townships were established by the 16<sup>th</sup> century. All these sites, as well as the farm at Corran, also appear on William Roy's map of 1747-52, which gives us some clue as to the ways in which the landscape was organised, in the period just before the land improvements of the late 18<sup>th</sup> century. This is particularly the case of Kilchamaig, which on Roy's map can be seen to be enclosed by a substantial boundary (Figure 50). Several field boundaries were recorded around Kilchamaig, including two that Mr Mundell, the current farmer, identified as being the original extent of the farm. The northmost field boundary (SCAPE ID: 16929, Figure 51), which is no longer in use, as the farm was extended north in the mid-20th century, is defined by a tumbled dry-stone wall, incorporating a bedrock outcrop and standing about 1m in height, extending for 50m into the intertidal zone. The southern boundary is defined by a significant field boundary (SCAPE ID: 16981), consisting of boulders stacked up to three courses high and 4m wide, extending some 60m into the intertidal zone. This boundary is still in use with an electric fence running along its length. It is possible that these field boundaries are the ones that

Figure 51. The northmost field boundary at Kilchamaig (SCAPE ID: 16929)

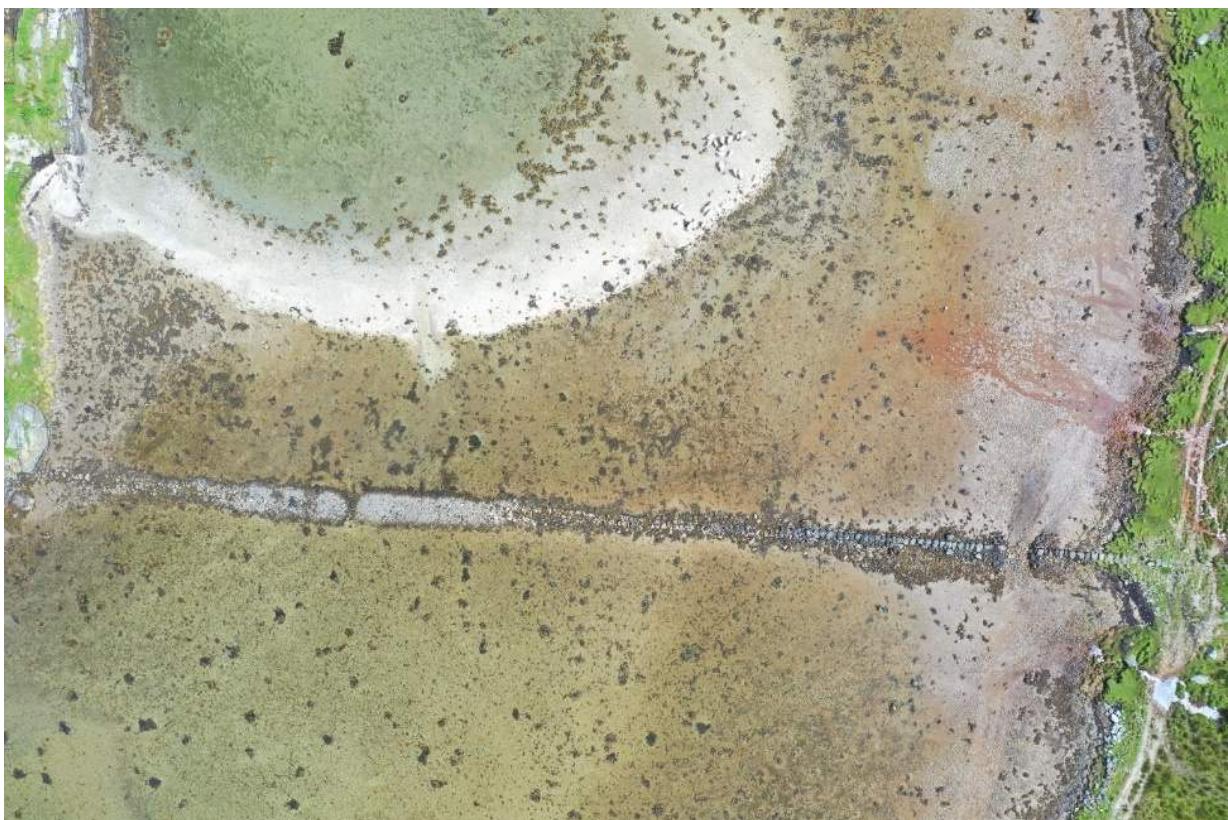
The majority of all the other intertidal extensions of field boundaries, some of which are very finely constructed (e.g. SCAPE ID: 16829, Figure 52), recorded during the survey are associated with animal husbandry and may relate to land improvement and enclosure in the late 18<sup>th</sup> and 19<sup>th</sup> centuries. All these sites appear to be relatively stable and in areas of

little predicted coastal erosion however, given their ephemeral nature and their intertidal location, then they are all, to a greater or lesser extent vulnerable to erosion.

Figure 52. Aerial shot of field boundary (SCAPE ID: 16829) north to the top of the picture.

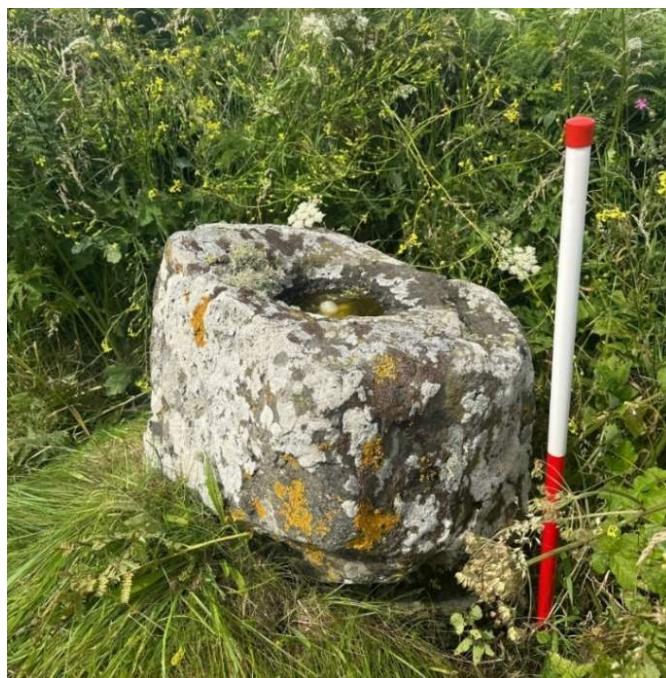
The stone itself measures around 0.6m cubed with a hollow font-like depression on top and it appears to sit on top of another stone. When we visited the site there were several quartz pebbles and coins within the hollow. The stone sits just above the shore, next to a small burn or drain in a very overgrown area. This section of coast has seen some erosion since 1900 and so there is a slight risk of long-term vulnerability to coastal erosion.

Figure 53. “The Rat Stane” (SCAPE ID: 16786)

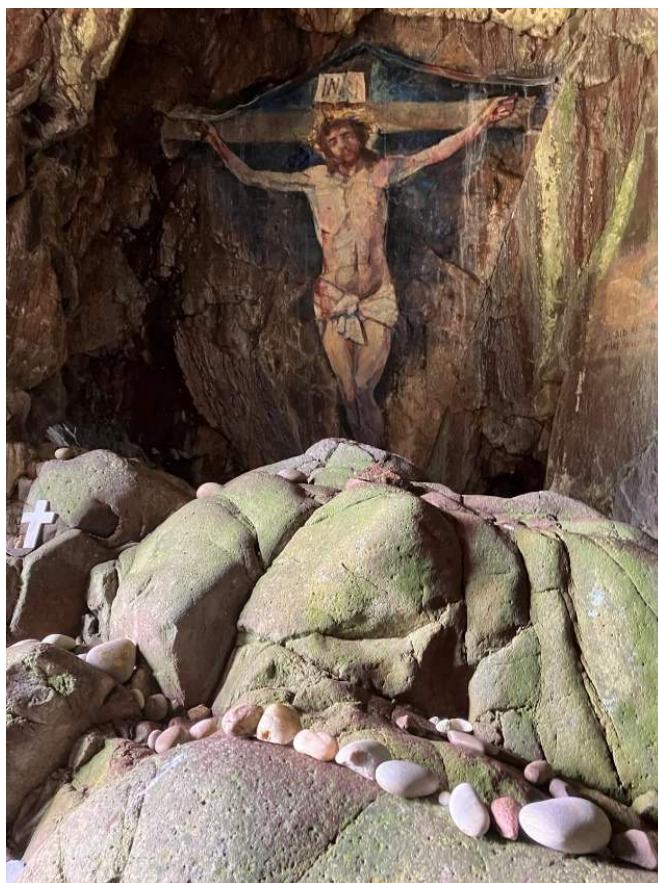
A well-known and unusual religious site is to be found within a cave on the southern shore of Island Davaar where local artist Archibald MacKinnon painted the Crucifixion on the cave wall in 1887 (SCAPE ID: 17005, Figure 54). The site is well visited by tourists and has become a place of pilgrimage. The painting has been restored several times, including twice by the original artist, and most recently in 2006 after it was badly vandalised. While

there are currently no issues to the site from coastal erosion, the painting is vulnerable to deterioration caused by the coastal cave environment while the continued threat of vandalism remains.

Figure 54. Island Davaar cave painting (SCAPE ID: 17005)

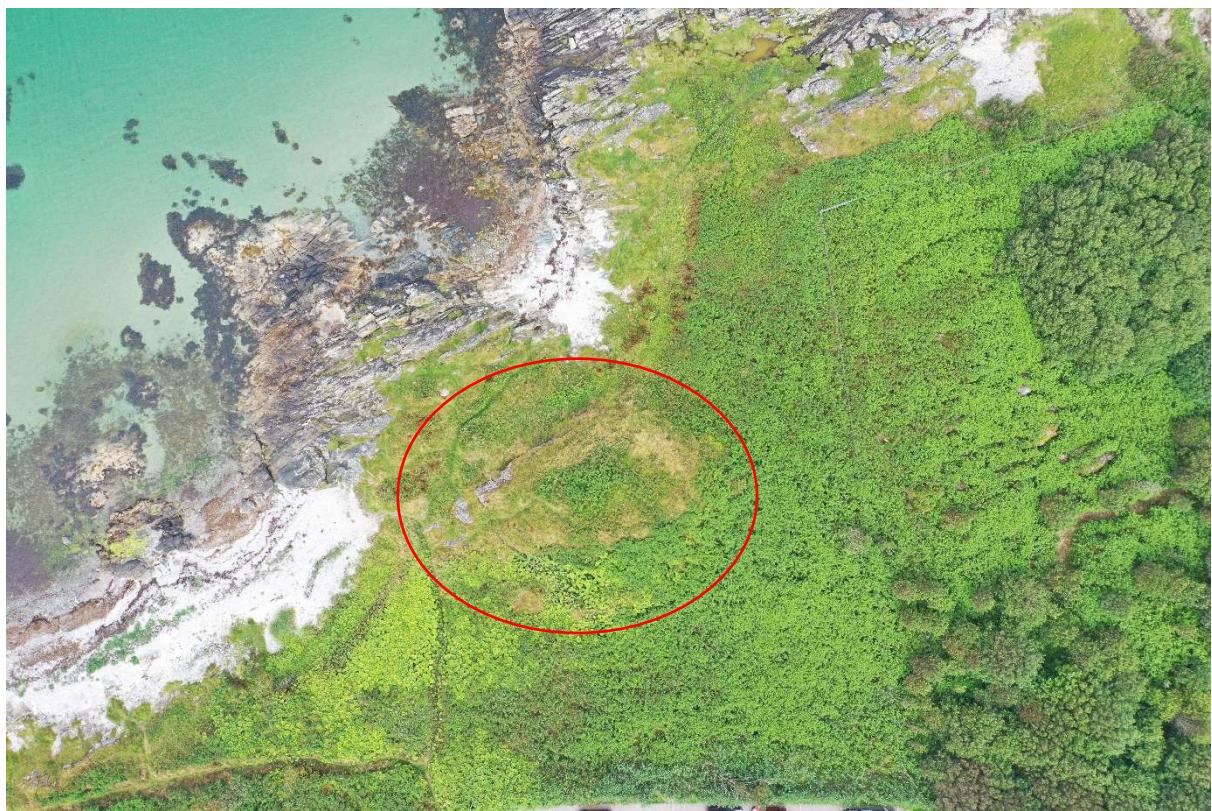
Three duns were visited during the survey, one at Ronachan Bay and two at either end of Macharioch Bay in the south of the peninsula at Dun Dubh and Dun na h-Oighe. The Dun at Ronachan Bay, which is a Scheduled Monument (SCAPE ID: 16798; SM3185; Figure 55) sits on top of a small, isolated knoll above the shore, and the wall that defines it can be made out in the higher vegetation and grass that covers the site, defining an oval area 24m x 18m in extent. Dun Dubh (SCAPE ID: 16788) is almost completely obscured by gorse bushes, and its outline, measuring 12m x 9m, is only discernible in the higher vegetation compared to the centre and outside slope of the site. A monument to the 8<sup>th</sup> Duke of Argyll occupies the middle of the site. Dun na h-Oighe (SCAPE ID: 16787, Figure 56) is a natural rocky headland, the summit some 18.0m long and 5.5m wide. There is no trace of walling around it, but a gradually shelving area on the northwest and north side gives the impression of turf-covered banking, which may or may not be artificial. If artificial there is a slight possibility that it formed a dun outwork, with the dun based on the top. None of these sites are being affected by coastal erosion, but dense vegetation hinders their understanding.

Figure 55. Aerial Shot of the dun at Ronachan Bay (SCAPE ID: 16798; SM3185), highlighted in red. North to the top right of the photo.

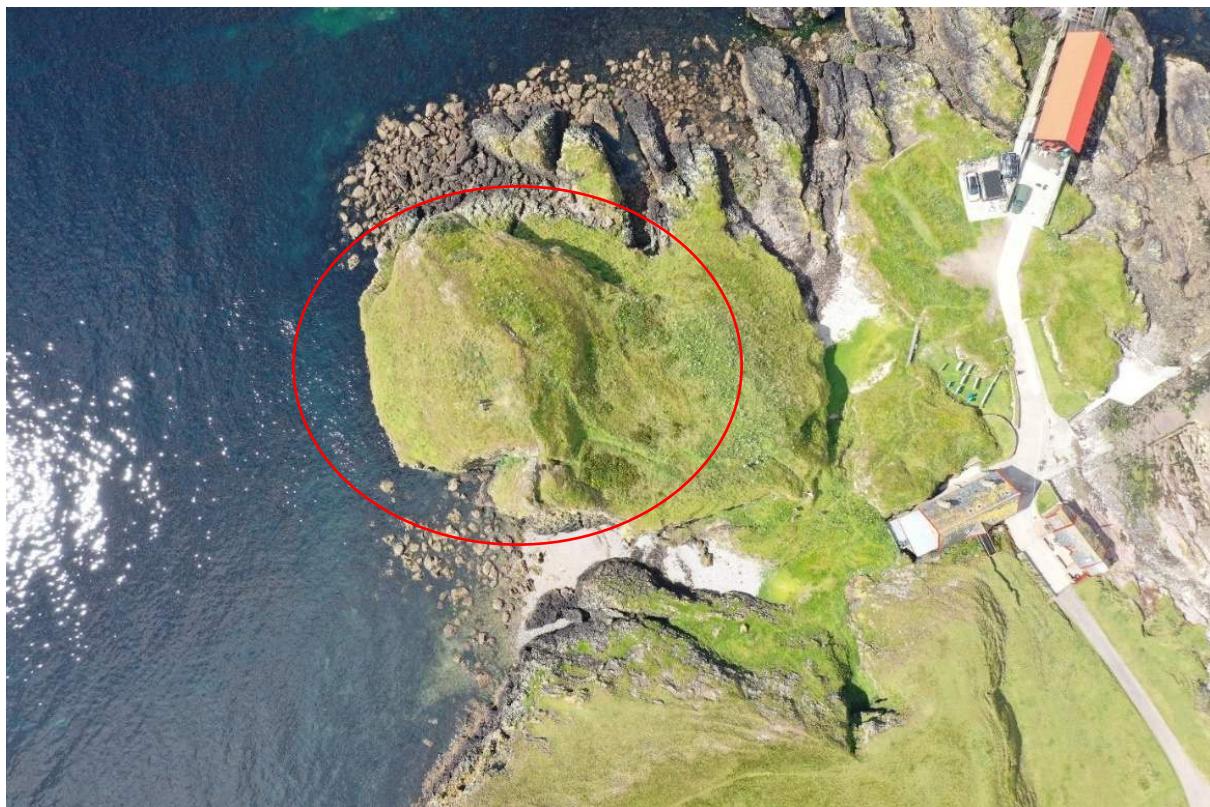
Figure 57. Aerial shot of Dunaverty Castle (SCAPE ID: 16762; SM3041). North the right of the picture.

The site of Dunaverty Castle (SCAPE ID: 16762; SM3041; Figure 57), which occupies the summit of a precipitous headland between Dunaverty Bay and Brunerican Bay was also visited during the survey. No trace of the castle was seen, apart from the rock-cut stairway that leads to the summit of the site, but records do describe some traces of mortared masonry. While the site is exposed to the full force of the Atlantic, it appears relatively stable and is not being affected by coastal erosion.

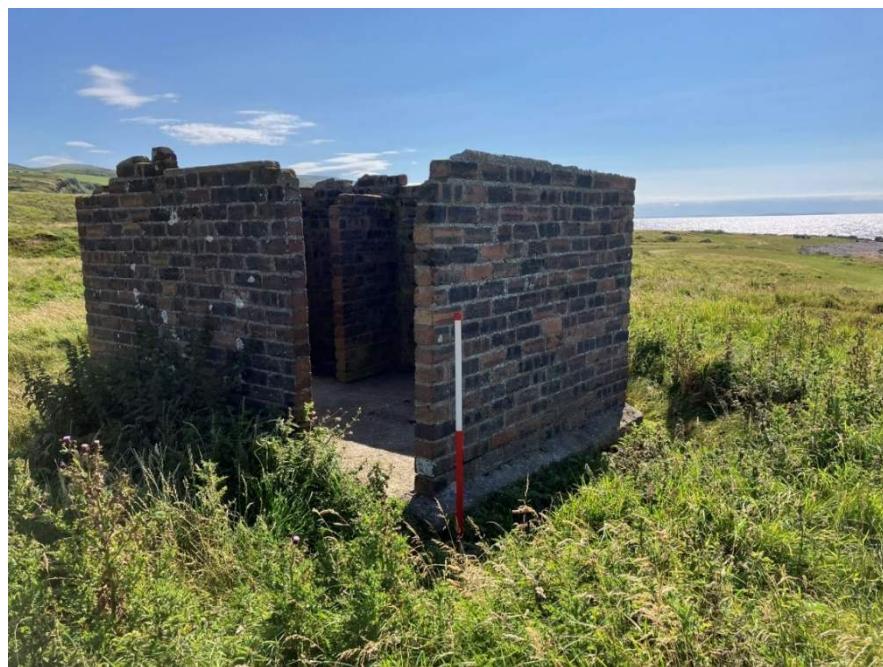
Figure 58. The WWII observation post (SCAPE: 16816)

Most of Kintyre's wartime military activity centred on Campbeltown and Machrihanish and lay outside the coastal survey area. However, a World War 2 and later Royal Observer Corps (ROC) observation post (SCAPE: 16816, Figure 58) was recorded at Usaed, comprising a small brick building with two compartments. The south compartment was probably roofed with corrugated iron sheeting as suggested by the impression of sheeting on the wall head on the south elevation. The north compartment contained the observation equipment with the entrance in the northeast corner. The post was established at this location in July 1942 and remained in use as an observation post for the nearby Machrihanish Airbase, until 1960. Three large concrete tethering blocks (SCAPE ID: 16973) recorded in the intertidal zone to the east of the Doirlinn, between the mainland and Island Davaar, may also have had a military function.

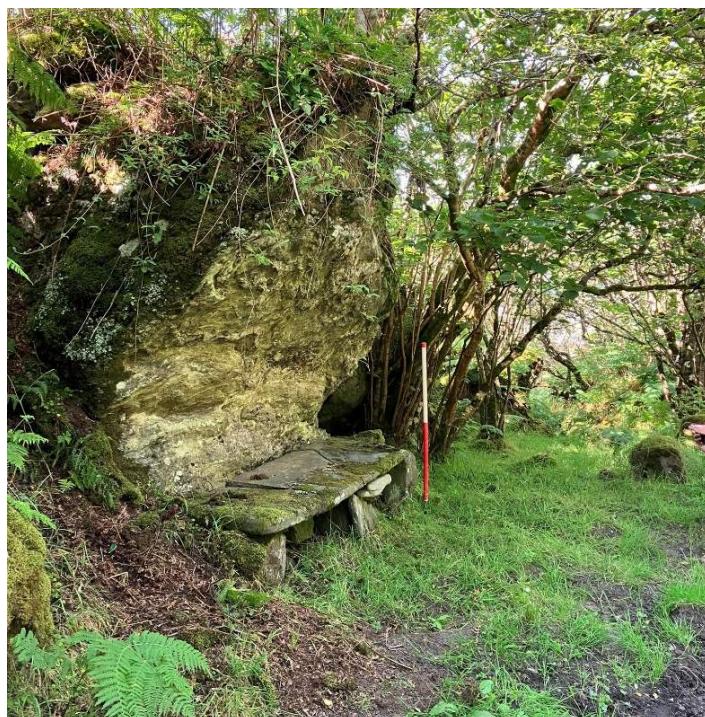
*Figure 60. Stone Bench (SCAPE ID: 16949) looking north.*

On the side of a historic track from Clachan to the ferry at Portachoillan are two stone benches (SCAPE ID: 16949 & 16950, Figure 60) known locally as the Skye Men seats after the men from Skye who built the track in the 19th century. Worn initials are carved into them and they must have provided a welcome resting place on the long walk between the ferry and the village.

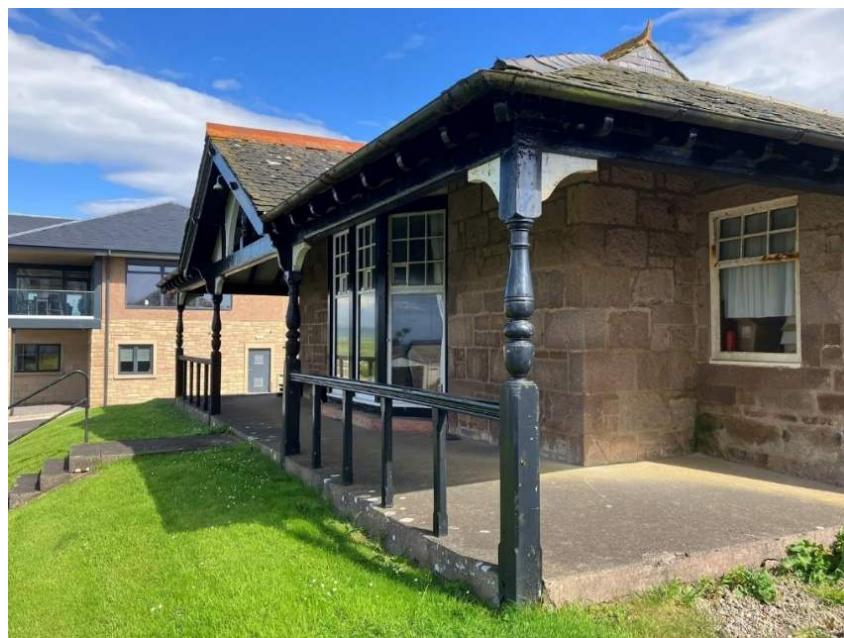
Figure 61. The Ladies Clubhouse (SCAPE ID: 16828; LB52262).

One of the main reasons tourists came to Machrihanish was for golf, with Machrihanish Golf Course, partly designed by the legendary golf course designer Tom Morris, opening in 1876. As the popularity of golf increased the Machrihanish Ladies Golf Club was formed in 1890 and at first, played on its own 9-hole course. This led to the building of what is thought to be the earliest purpose-built Ladies' golf clubhouse in Scotland, designed by H E Clifford, in 1893. The building (SCAPE ID: 16828; LB52262; Figure 61) which is a Category B listed building, is currently unoccupied and is falling into disrepair but local information suggests that it is going to be refurbished in the future.
